CODE AMENDMENT FORM

CODE: IECC SECTION: R402.2.9

Spray Foam Insulation and Subterranean Termite Inspection Issues

Spray Polyurethane Foam / Termite Detection Demonstration Project (July – August 2019)

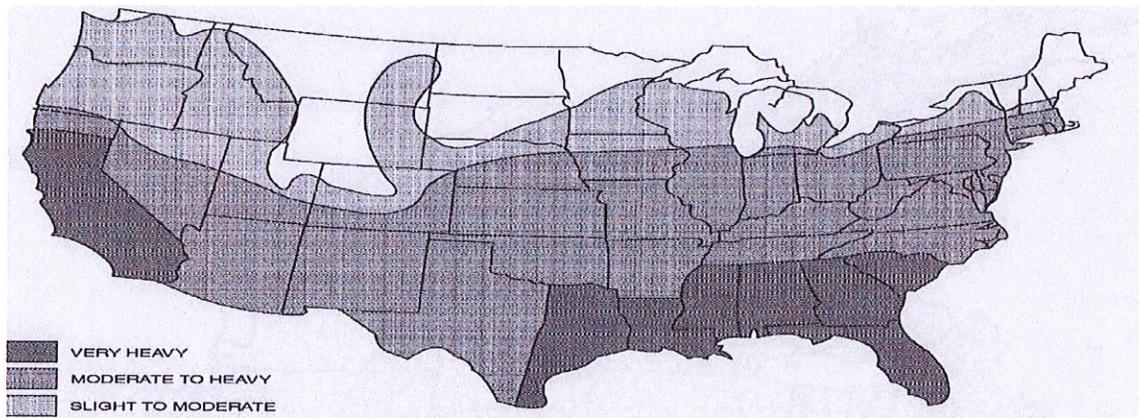
Figure 1. 2015 IRC Table R 306.1.2 (6) Subterranean Termite Map

In the regions where subterranean termites are active, as shown in 2015 IRC Table R301.2.(6), (Figure 1), the use of SPF has created an issue with termite inspections. The areas of the building where SPF most commonly interferes with subterranean termite inspections are basement and crawl spaces in which SPF has been installed on the foundation walls, the mud sill and band joist areas. This assembly is known as a sealed or semi-conditioned crawl space, which requires the assembly to be insulated and have a continuous air barrier installed by code. The building industry has increasingly moved to using SPF to achieve its insulation and air barrier objectives. Building codes in Georgia and a few other states (NC, AL & MS) require 3" termite inspection gaps (no foam) at the top and bottom of the foundation wall, but still allow the band joist and mudsill to be covered with SPF. However, the installation of SPF on the band joist and mudsill covers the critical areas that the pest management companies need to visually inspect. The mudsill, band joist and joist ends are the first points at which termites can be detected as they enter the wood structure. Subterranean termites can pass through small 1/32" to 1/64" cracks and gain access to structural or decorative lumber by constructing shelter tubes and climbing up the inside or outside of the foundation wall. Termites can also enter buildings through cracks in the footing and traveling through voids in concrete masonry units. Inspection opportunities from the exterior of the building are often obstructed by brick or landscaping features, so inspection from inside the crawlspace is the only option. There are currently no alternative "viable" inspection methods or tools available to perform the inspections through SFF (see attachment "A": "Spray Polyurethane Foam / Termite Detection Demonstration Project" completed by Dr. Brian Forschler, University of Georgia, Athens GA). Additionally, visual inspections are required by some states and mortgage companies.

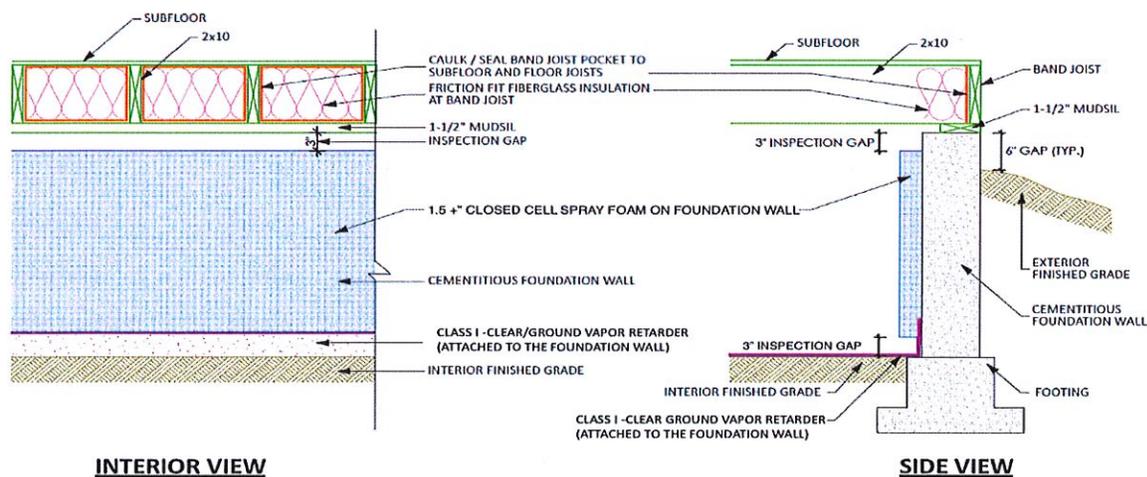
Drawing 1

Unvented/Sealed Crawlspace with 1.5 +” Closed Cell Spray Foam on Foundation Wall and Removable Insulation on Band Joist

The overall solution to improve building performance and permit visual termite inspection is to provide the code required 3" inspection gaps on the top and bottom of the foundation wall and prohibit the installation of spray foam over the band joist and mudsill. The framing members would need to be caulked at the joints connecting the floor sheathing above, to the top of the foundation, as can be seen on Drawing 1. A non-rigid, removeable insulation, such as a fiberglass batt, would then be placed in the "pocket" to insulate the band joist and the mudsill. This will take extra time but will allow for the periodic inspections required to maintain termite warranties/bonds. Additionally, consumers will be able to take advantage of both valuable services, SPF and termite control.

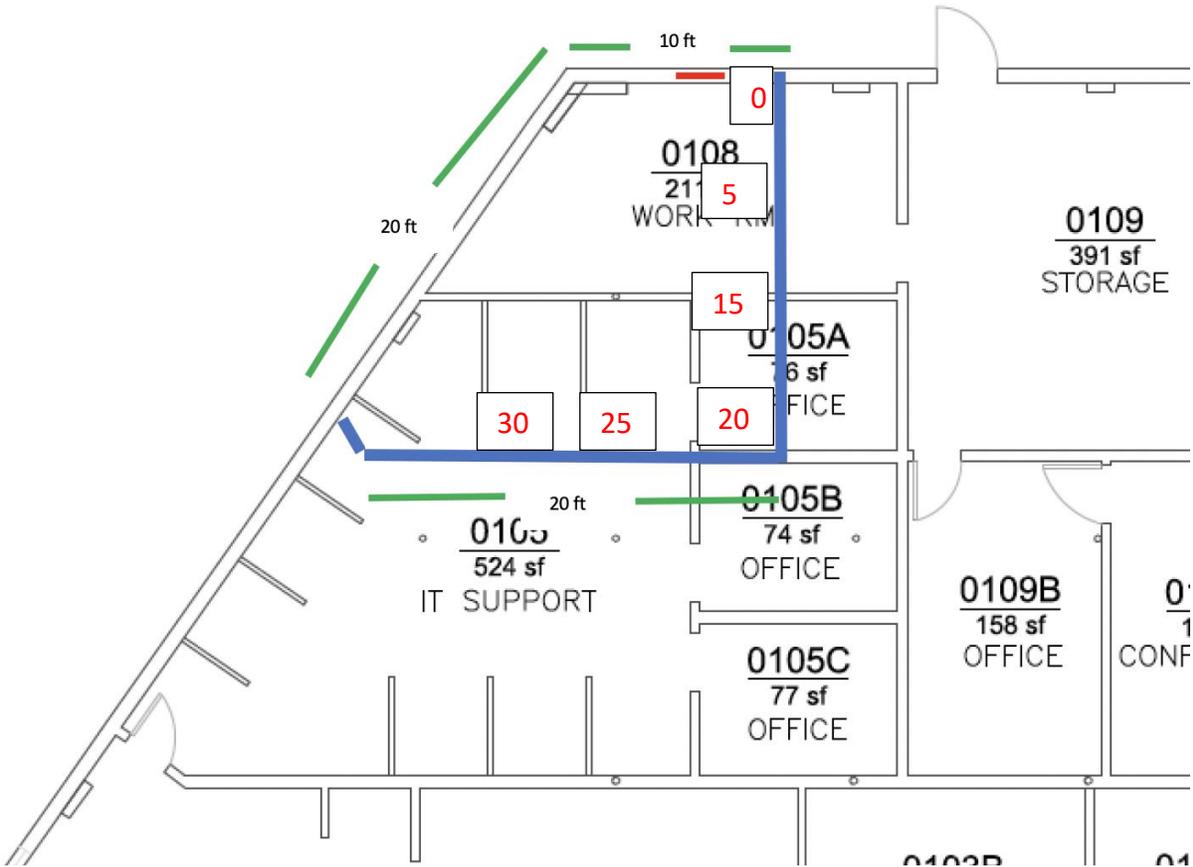
Site Description: The crawlspace measured 20X20X20X10-ft and was installed during a renovation of the building in 1999 (Figure 1). The crawlspace was defined by hollow block walls approximately 7-ft high with wood framing for the floor with four hollow block piers and one metal pole as supports for the floor in the center of the space. A vapor barrier was placed over the soil floor of the crawlspace on July 15, 2019.

Figure 1. Diagram of the crawlspace from the building floor plan with blue lines delimiting the interior foundation walls that define the crawl, green lines approximate distances (in feet) of the crawlspace foundation and the red line indicates the location of doorway providing access to the crawlspace. The Location numbers discussed in the report are posted in white boxes in red font with Locations O and 20 on the hollow block wall in the south east and southwest corners, respectively, and Locations 5, 15, 25, and 30 on the joists and joist headers on the south and west walls, respectively.

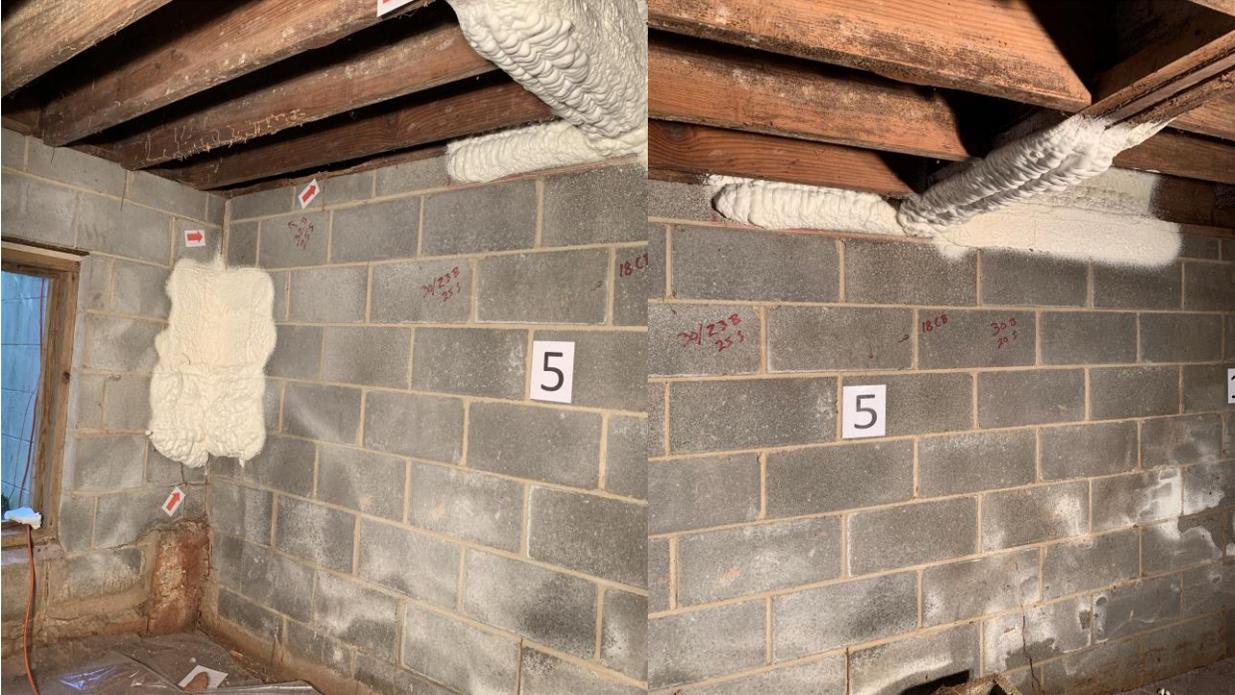
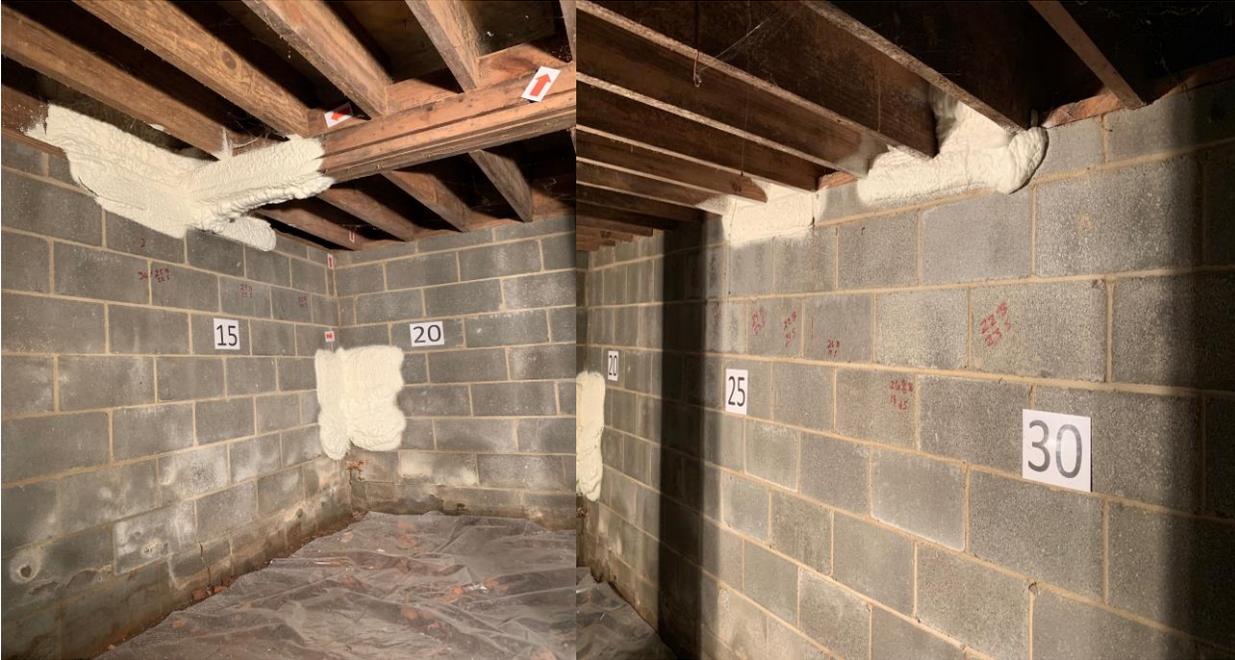
SPF foam was applied to the shelter tubes at locations 0 and 20 and on the sill, joist header and beams at locations 5, 15, 25 and 30 (Photograph 1; Figure 1). Two types of SPF were applied at each location, closed cell SPF at 2-3 inches and open cell SPF at 6-8 inches thick.

The results from the visual inspections included the obvious, intuitive, observation that visual inspection was prevented following application of SPF to either the wood or hollow cinderblock construction materials (Table 2). Visual inspections are subjective, and inevitability, grounded in the experience of the individual inspector and circumstances at the time and place of the inspection. This point is evident in the summary of the number of red arrows placed by each inspector on the first two inspection dates (Table 2). The number of points identified (with red arrows) using visual search between inspectors indicating evidence of termite activity clearly underscores the aforementioned subjectivity. The fact that three experienced termite inspectors went to the same crawlspace and identify three different number of 'active locations' indicates the experiential nature of reporting termite activity using visual inspection. The number of different locations identified by each inspector could have been a result of the fact that evidence of termite activity was widespread in that crawlspace (Photographs 1 & 2). The purpose of an

Photograph 1. Images of the locations discussed in the report where SPF was applied.

A. Locations 0 (not identified with a number; in the corner) and 5.

B. Locations 15, 20, 25, 30.

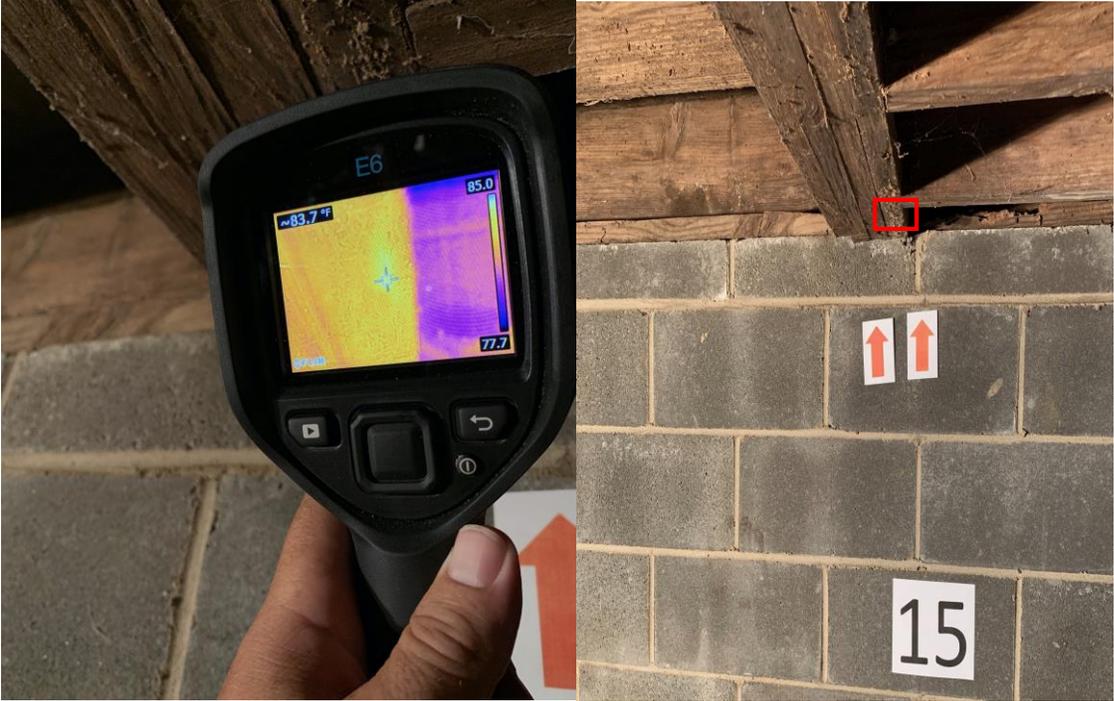
Surface temperatures on all substrates – block or wood – did not vary more than 0.9 degrees Celsius (1.6 degrees Fahrenheit) between any of the surfaces in the crawlspace with no pattern related to signs of termite activity. The Flir IR camera identified 1 area of termite activity on wood (Location 15) (Photograph 2) and 2 other termite-activity areas were associated with shelter tubes at Locations 0 & 40.

Photograph 2. Image of the IR camera screen (Flir E6) indicating an area determined to show termite activity during the first inspection (July, 17) and a visual image of the same area indicated by the red box (right).

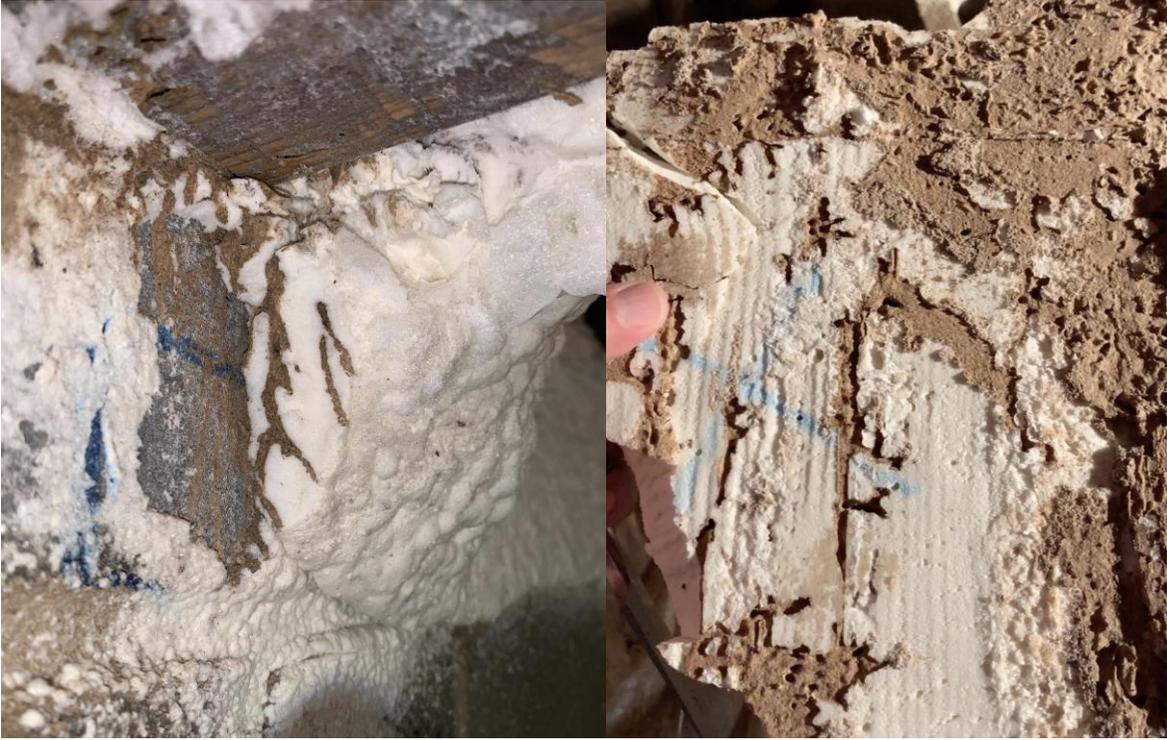
termites leaving the shelter tubes and entering the foam. Termites did, however, tunnel into the foam on the beams, joist header and sill at locations 5 and 15 and but not areas 25 or 30 (Photograph 3). There were hundreds of live termites in the foam removed from the aforementioned areas and live termites also were observed in the sill and beams at areas 5 and 15 by destructive sampling and with the borescope (Photograph 5).

Photograph 3. Images of termite activity in the SPF observed during the August inspection from the joists and joist header by Location 5.

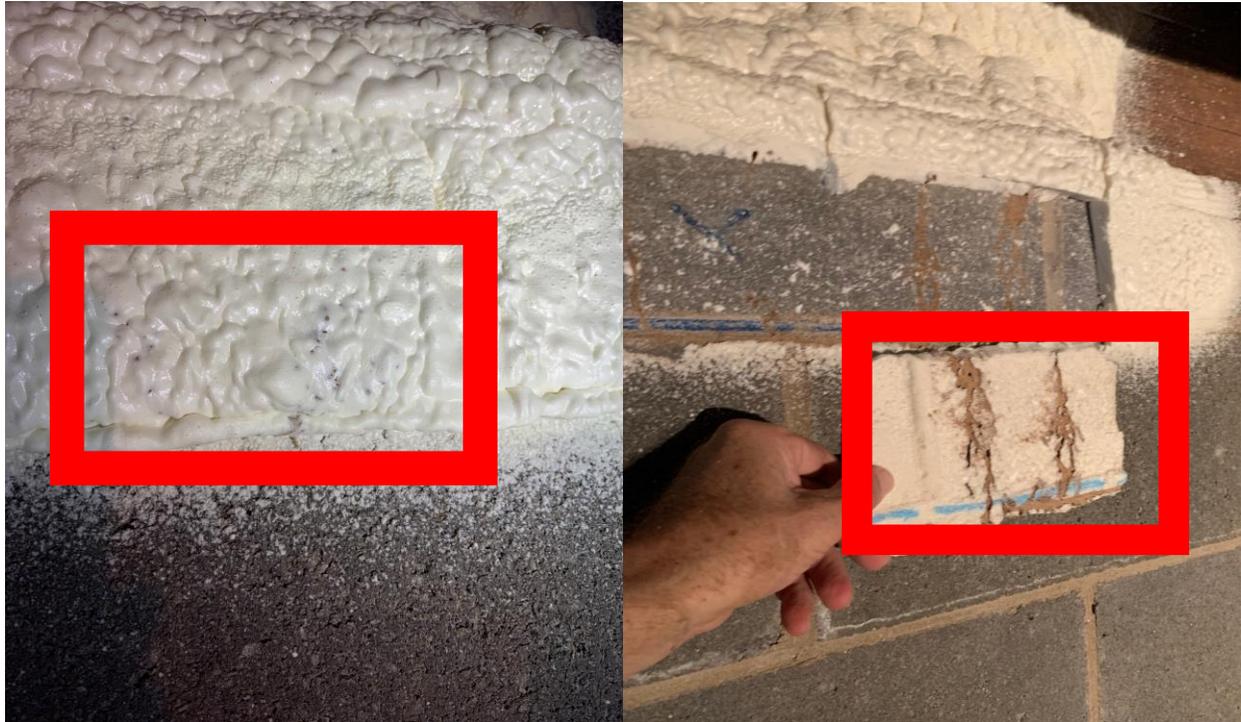
Picture 4. Images of the area in the SPF at Location 5 that provided visible evidence of termite activity on surface of SPF... left (outlined by the red box) and that same area exposed during foam removal.

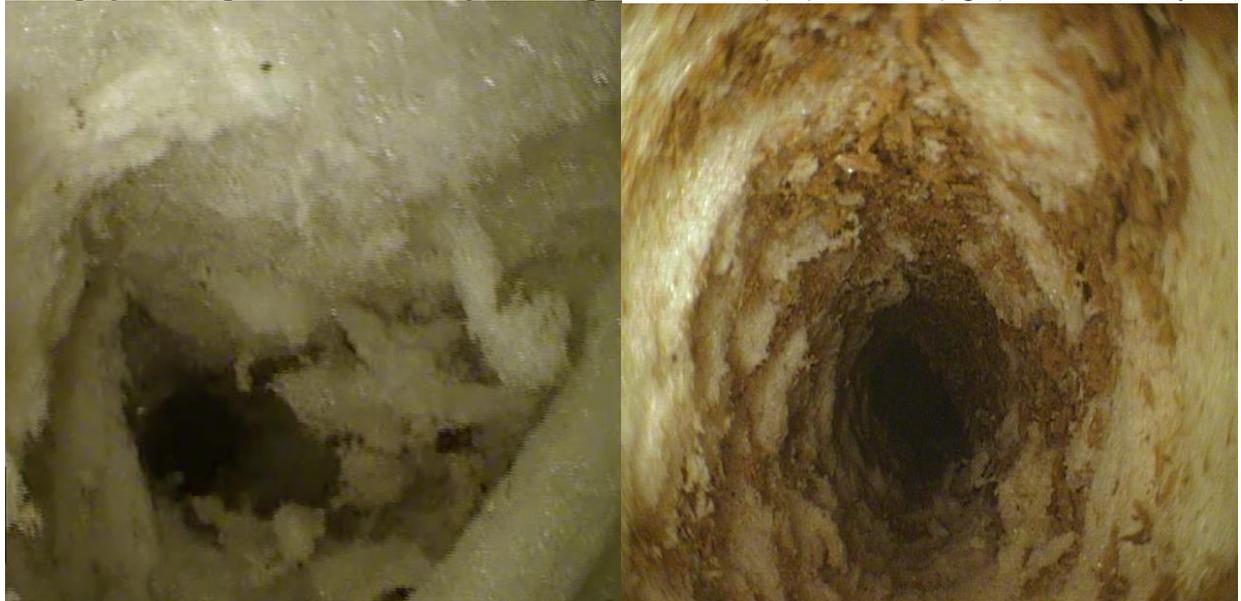
In addition, we used a XLVU Videoprobe borescope to verify termite activity in the wood behind Locations 5 and 15 as well as demonstrate that this device could also distinguish between infested and not-infested foam (Photograph 5).

The Termatrac T3i using the microwave motion detector provided evidence of termite activity with and without the foam (Table 1). Confirmation of termite activity was confined to the last (August) inspections when destructive sampling was conducted. There were no live termites found during the July inspections when shelter tubes at Locations 0 & 20% were broken nor where those sections of shelter tube repaired (after SPF application) the following day. However, one month after SPF application (August inspection) thousands of termites were observed in the foam and in pieces of wood destructively sampled with a chisel and the borescope as well as in shelter tubes at Locations 0 & 20 (Photographs 3- 5). Destructive sampling using the borescope provided evidence that by drilling 1/4-inch holes into SPF one can determine if termites are present (Photograph 5).

Photograph 5. Images from the borescope showing SPF without (left) and with (right) termite activity.

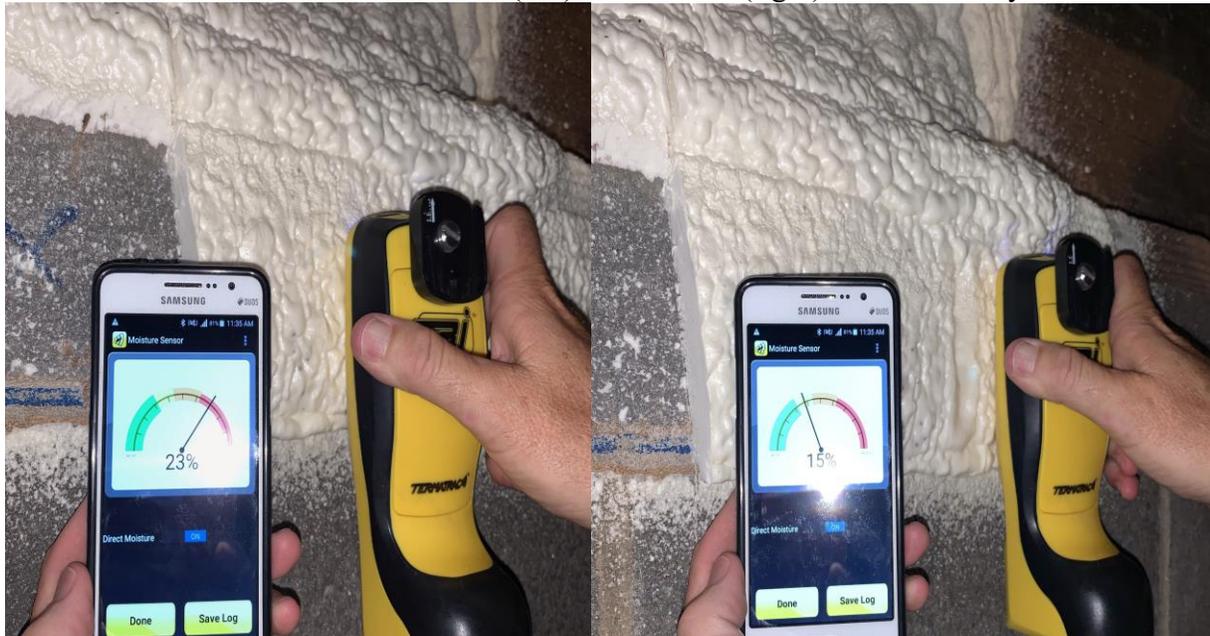
Moisture readings were taken on the area of visible termite activity in the SPF at location 15 and the only device that provided a different reading was the Termatrac T3i that showed 9-15% on the foam next to the area of visible activity and 17-23% on top of that location (Photograph 6).

The conclusion we were able to reach, given the parameters that defined this demonstration project is that the devices employed by the participants were unable to identify any consistent indication of termite infestation on the wood or block and certainly not *through* the SPF insulation. Additional research under varying conditions should be conducted to see how these same or other termite detection devices perform. The Termatrac T3i was the only device to provide moisture readings (17-23%) on the area of closed cell SPF with visual confirmation of termite activity that was different from the surrounding foam (14-15%) (Photograph 6).

Photograph 6. Image of the Termatrac T3i percent moisture readings on closed-cell foam at Location 5 on the block in an area with (left) and without (right) termite activity.

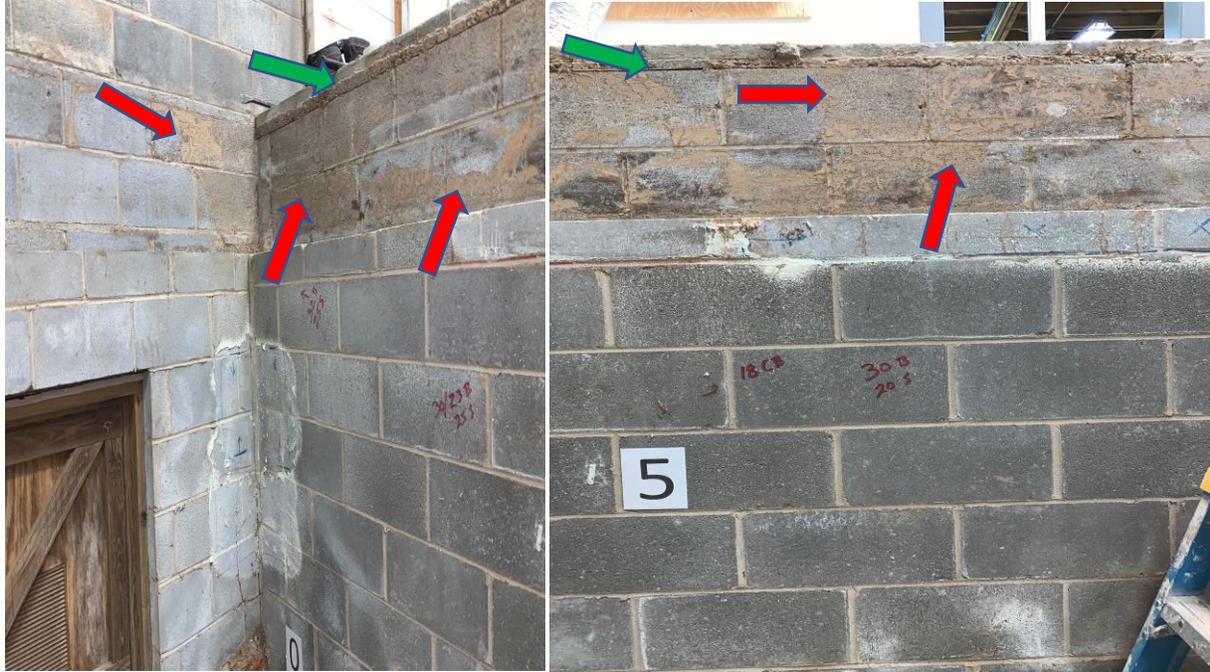
provided substantial evidence that this infestation was initiated in the sill and joist headers in the southeast corner of the crawlspace. The amount of termite feeding activity observed in the joist header, sill and floor joists (Photograph Supplement 1) in that area displayed a pattern showing more wood removed from structural lumber closer to the SE corner of the crawlspace.

Photograph 1. Images taken during the September 6th, 2019 renovations showing the termite activity, by the red arrows, along the block foundation wall behind the joist header in the southeast corner of crawlspace at locations 0 and 5. The infestation likely accessed the structural lumber from the expansion joint between the slab and block wall (green arrow).

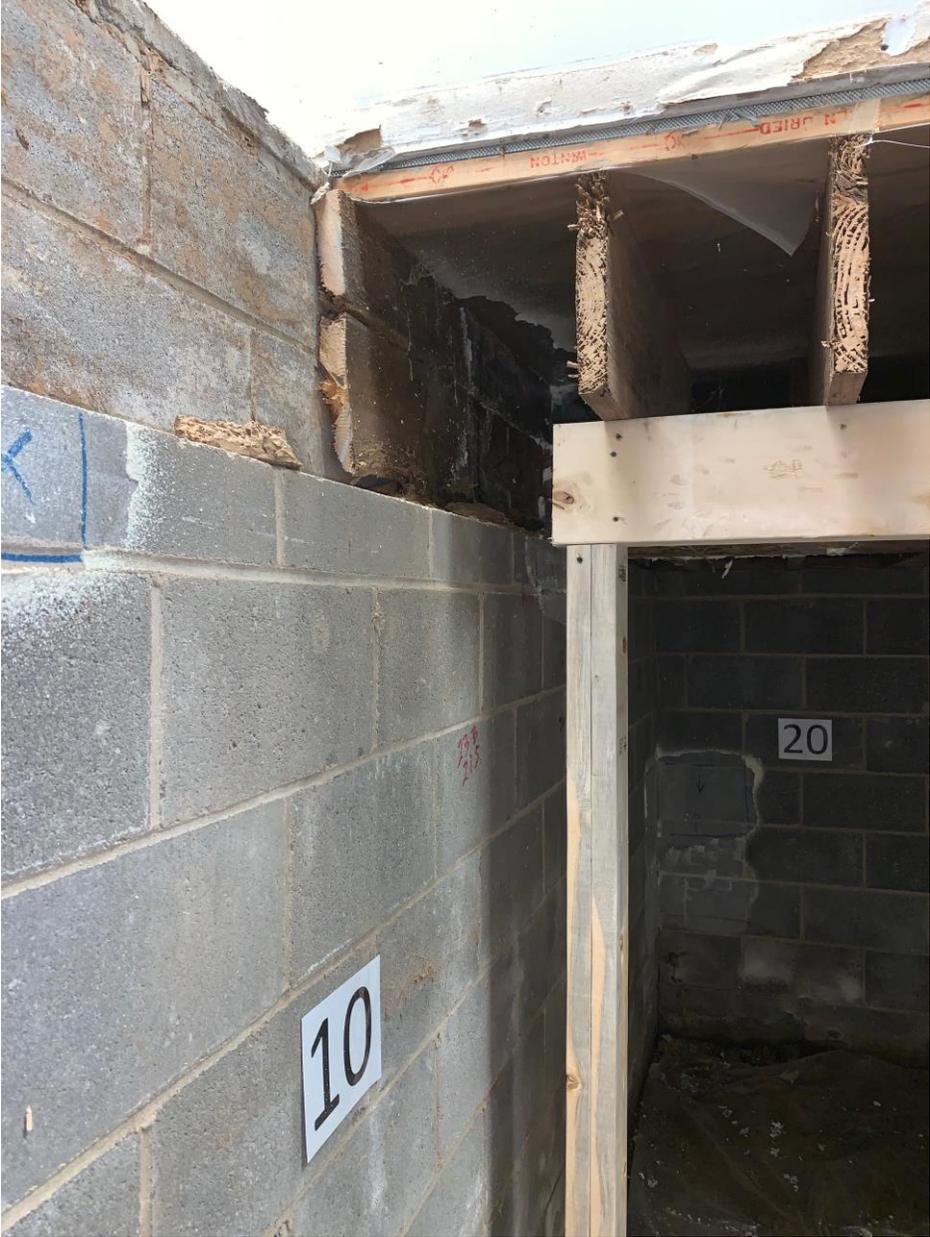
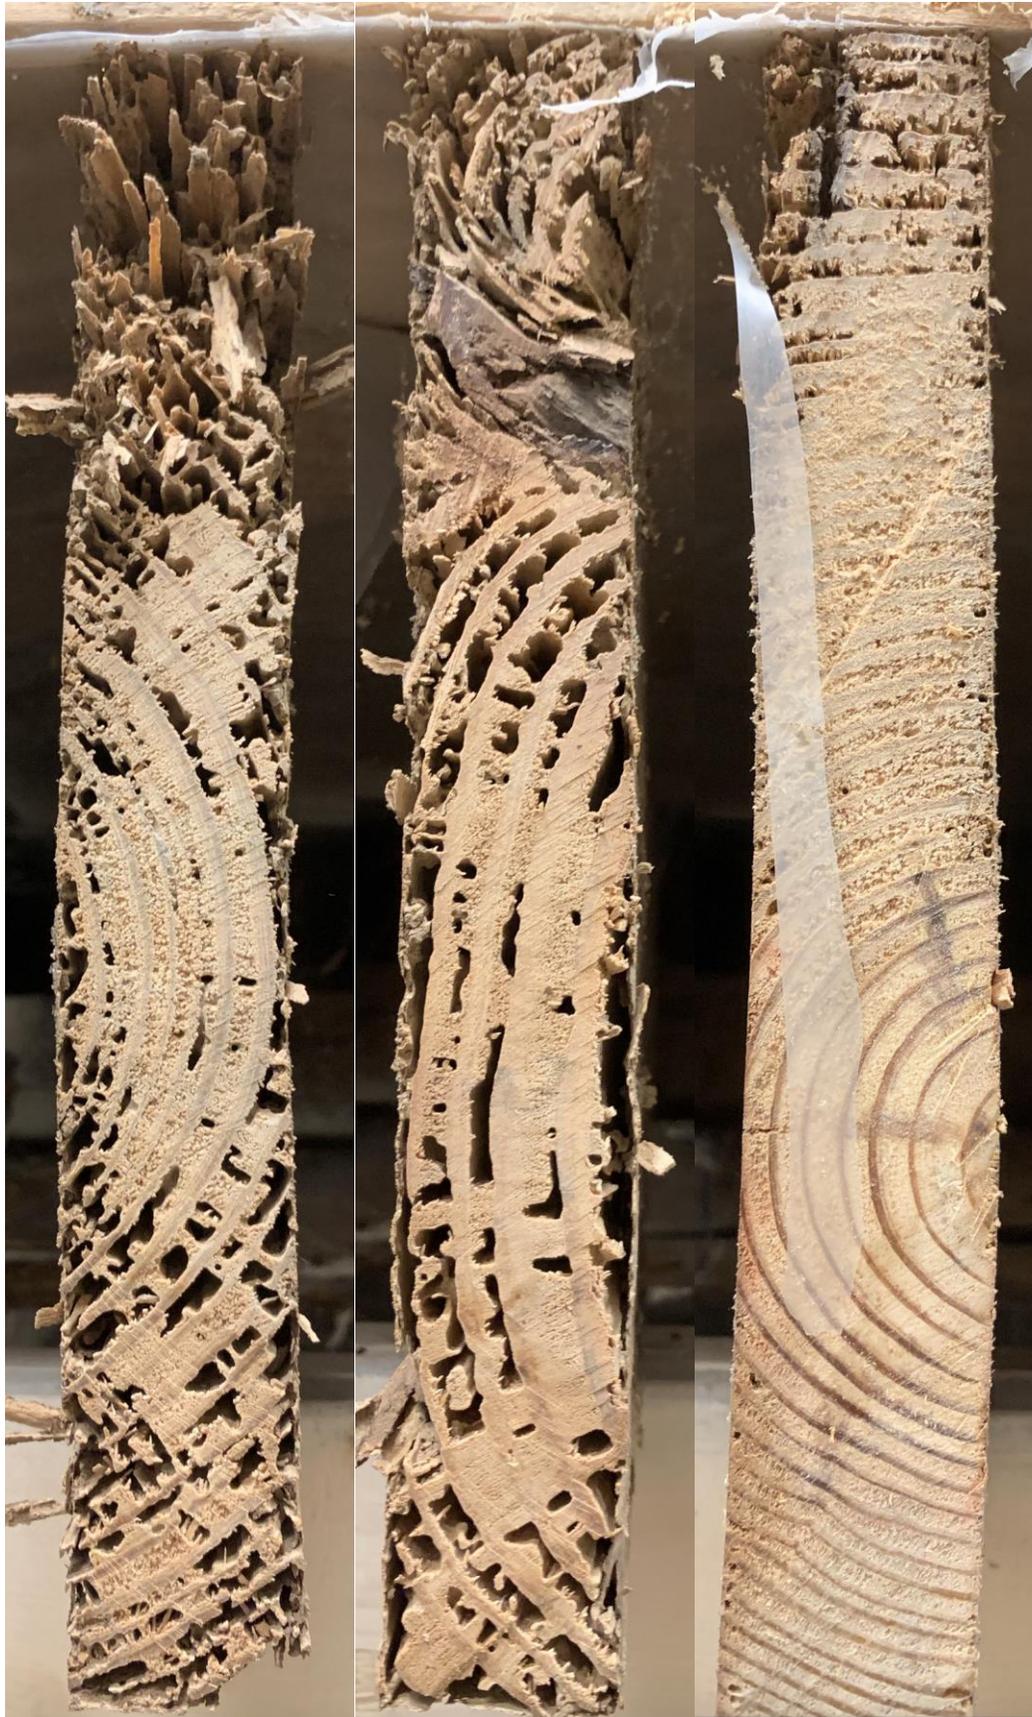
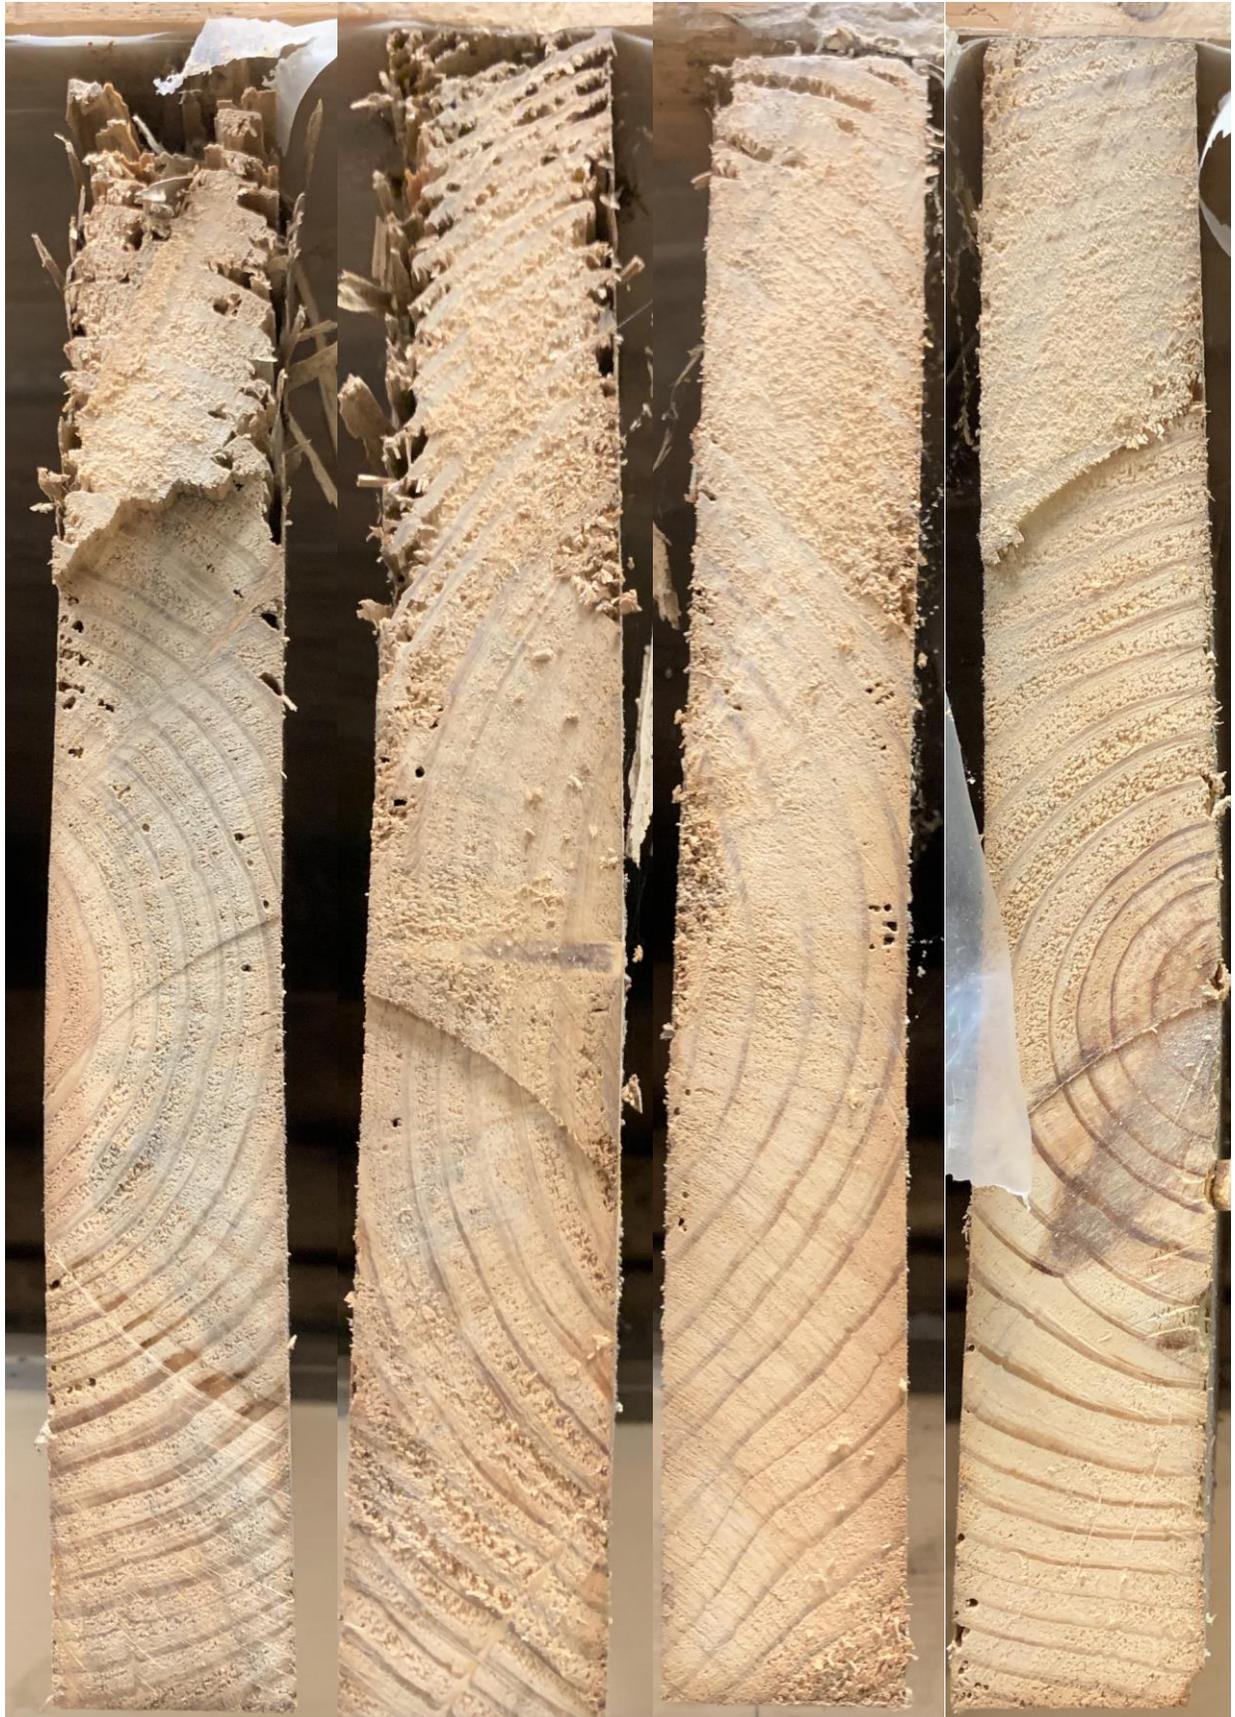
Photograph 2. Pictures of the floor joists between Locations 10 & 15 exposed during renovations conducted 6 September 2019. Pictures of each joist are arranged, left-to-right, by proximity to the joist header (on the left in this image) along the south wall of the crawlspace.
