PHASE I ENVIRONMENTAL SITE ASSESSMENT

**WOODLANDS VILLAGE APARTMENTS PHASE I & II  
1201 WEST NORTH MAIN STREET  
LAFAYETTE, WALKER COUNTY, GEORGIA  
GEC JOB #120313.240**

**JUNE 12, 2012**

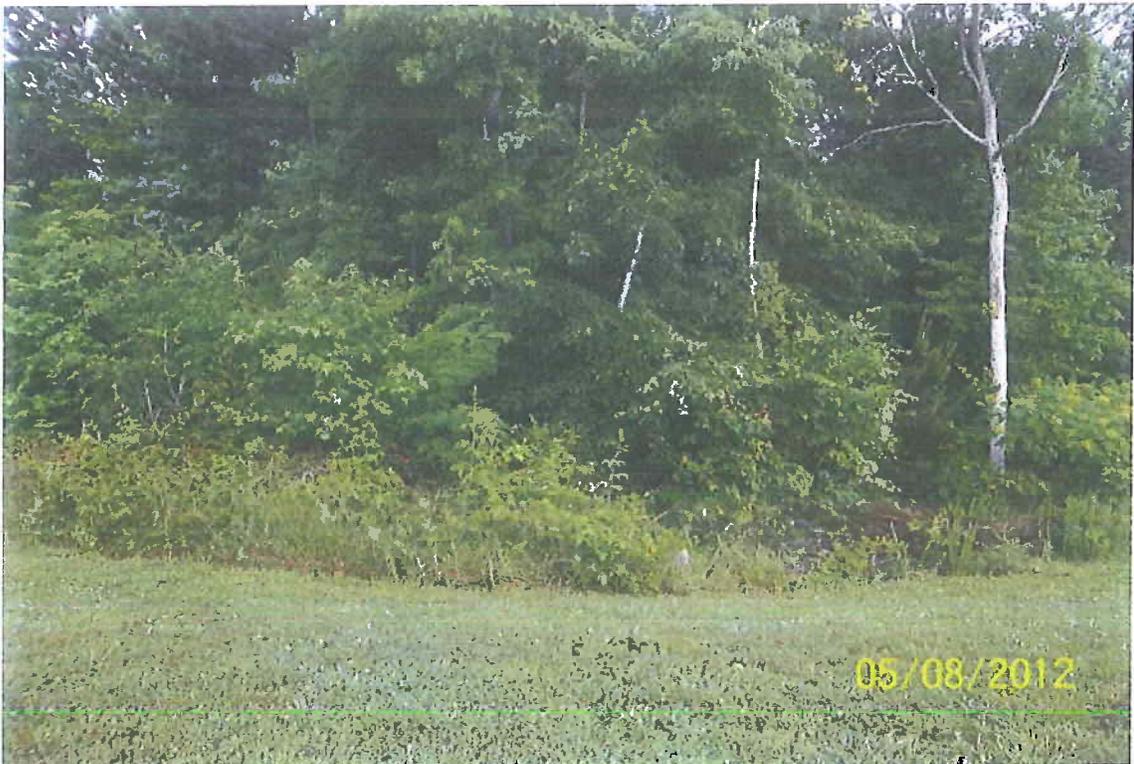
**Photograph 20**

View to the southwest from the central portion of the subject property west of the buildings; drainage swale for stormwater control

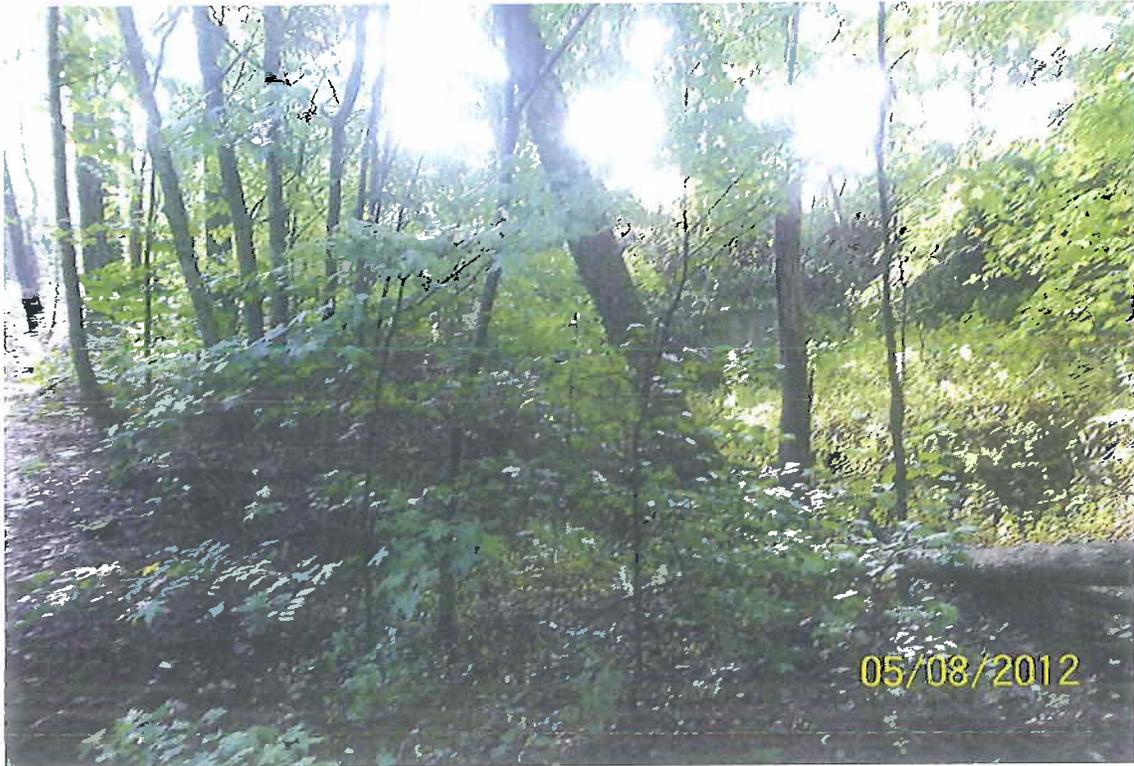
**Photograph 29**

View to the south from the northeastern portion of the property at the subject property's eastern detention pond

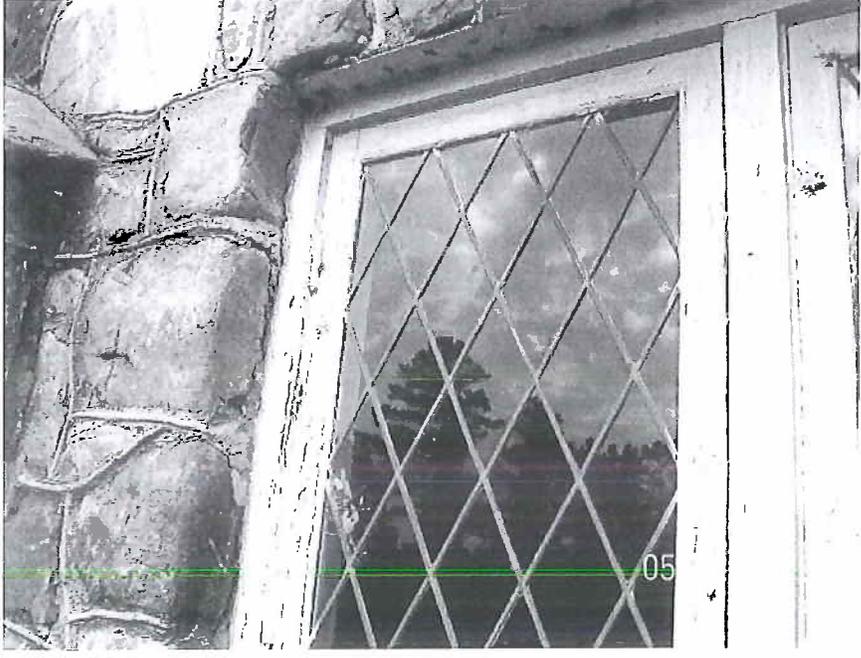
<p>A black and white photograph showing the interior of a window. The window is dark, and the trim is visible. A date stamp '05/12/2012' is in the bottom right corner. A metal fence is visible through the window on the left.</p>	<p><b>Interior window trim positive for LBP</b></p>

Based on the findings presented in this report, GEC found no obvious environmental concerns or risks associated with the subject property other than the asbestos and LBP abatement necessary for the community/office building; therefore, we recommend no further environmental study of the site at this time.

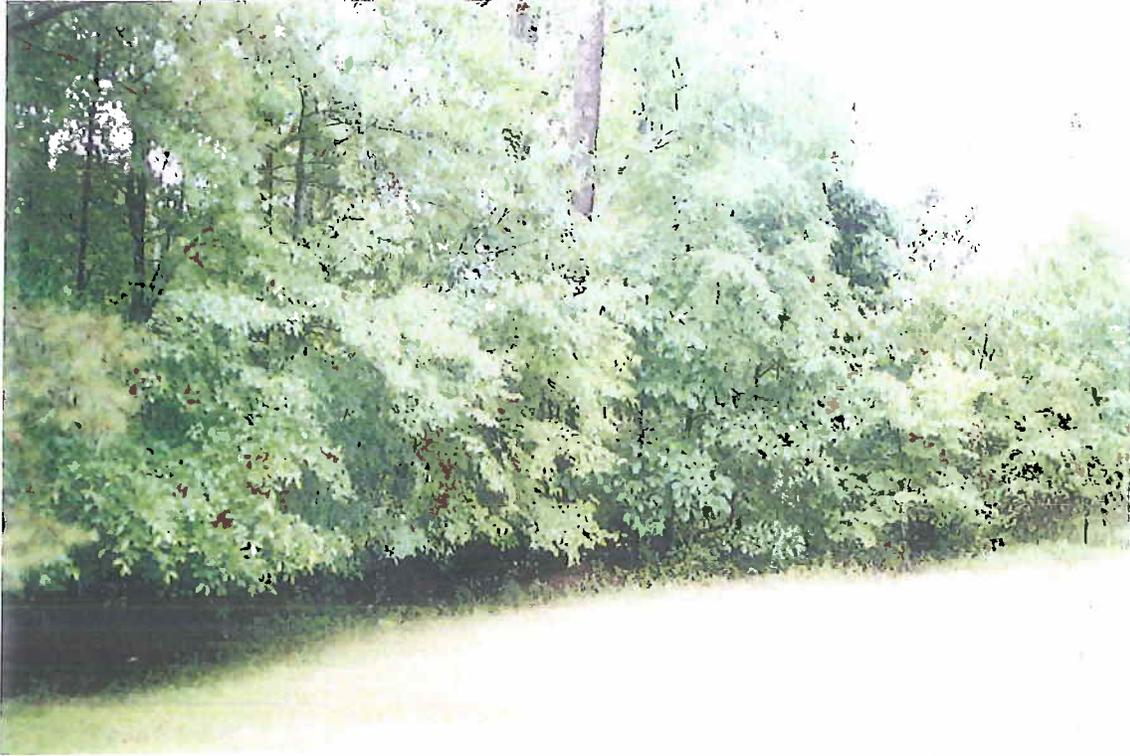
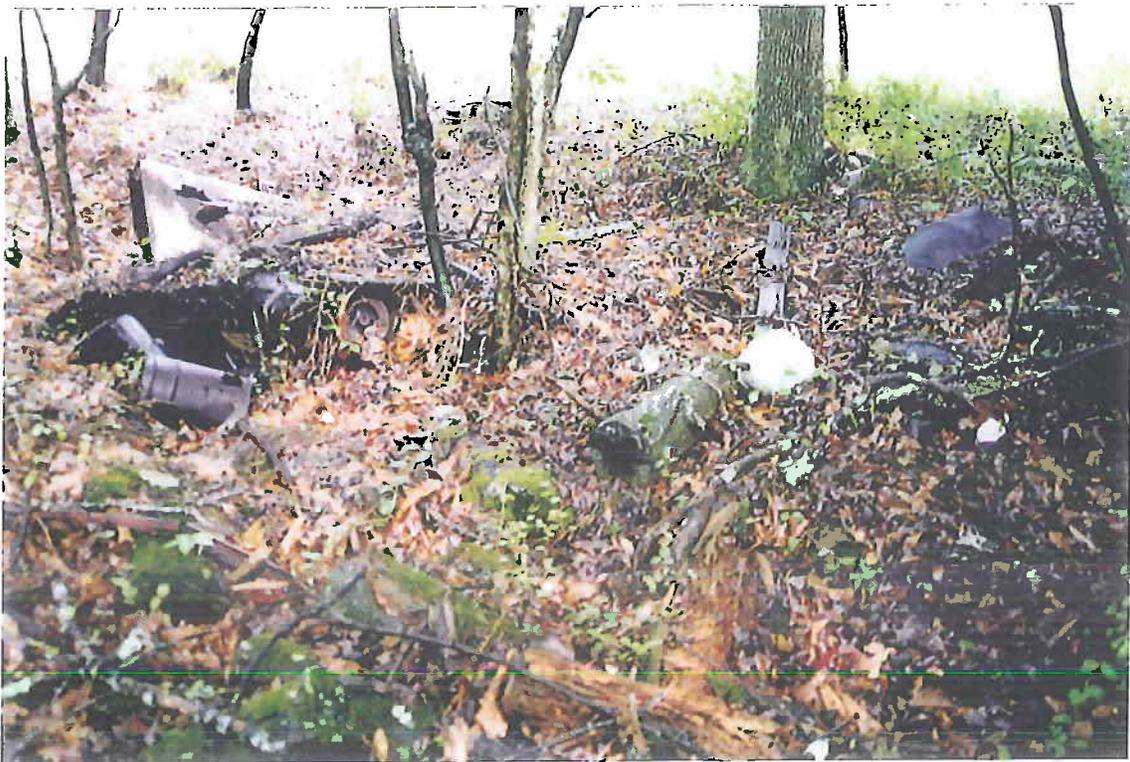
**PROPERTY IS HEAVILY WOODED BEHIND STRUCTUARES (TOP)  
DEBRIS DUMPED IN WOODS (BOTTOM)**
