ENVIRONMENTAL SITE ASSESSMENT

PROJECT: Autumn Manor
Beulah Dr (aka Centennial Parkway)
Dalton, GA 30721

PROJECT NO.: 12-034

REPORT DATE: June 12, 2012

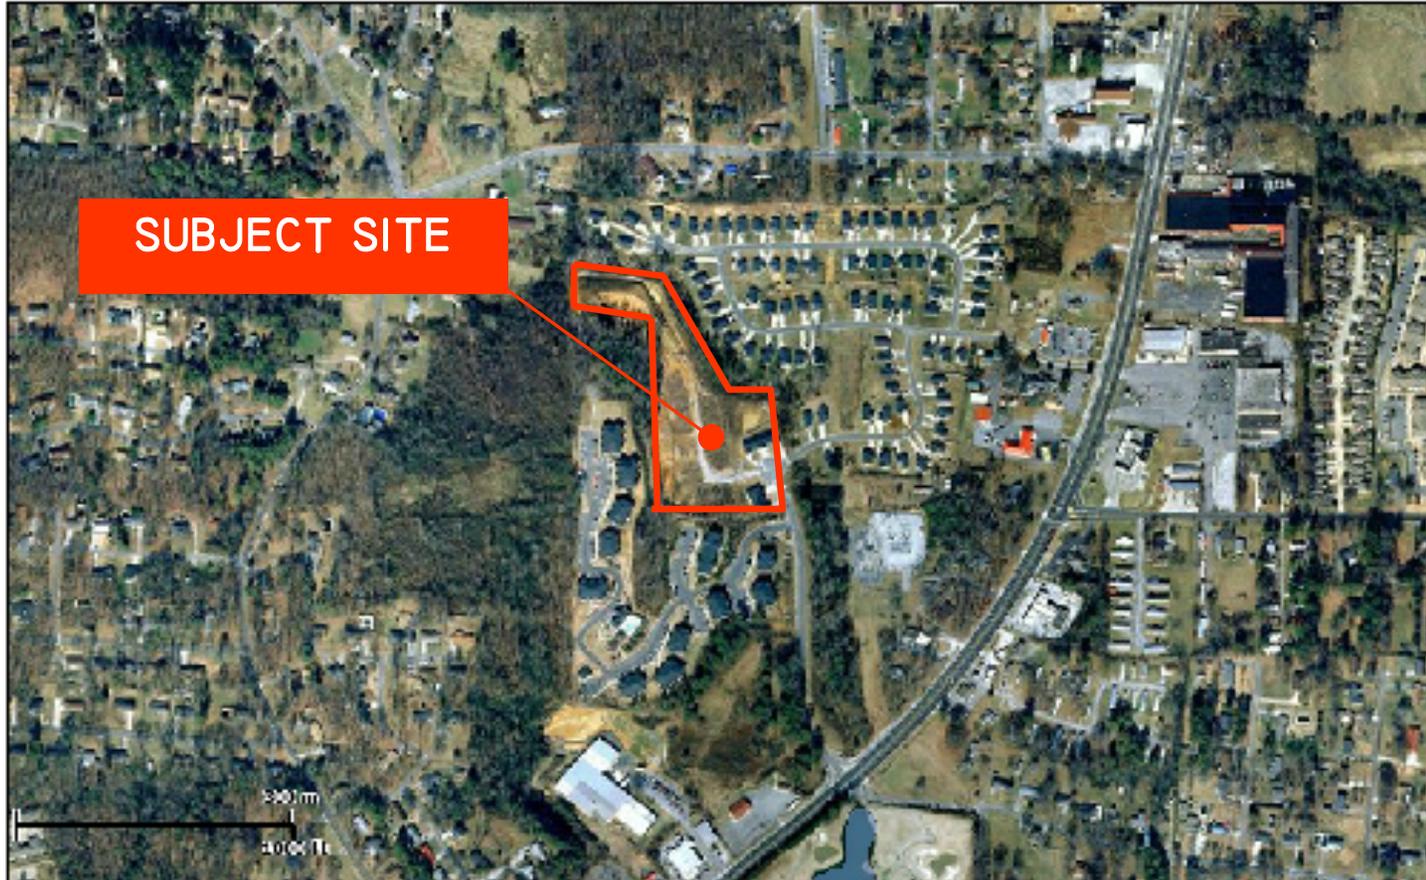
A review of the most recent National Wetlands Inventory map prepared by the U.S. Fish and Wildlife Service for Dalton, Georgia as of June 1, 2012 indicates no jurisdictional wetlands present in the vicinity of the site. No suspect wetlands were observed during the site reconnaissance. Additionally, since the site is already mass graded for a previous planned development, the potential for disturbing undocumented wetlands is extremely low. *It is our opinion that wetlands are not an environmental concern for this site.*

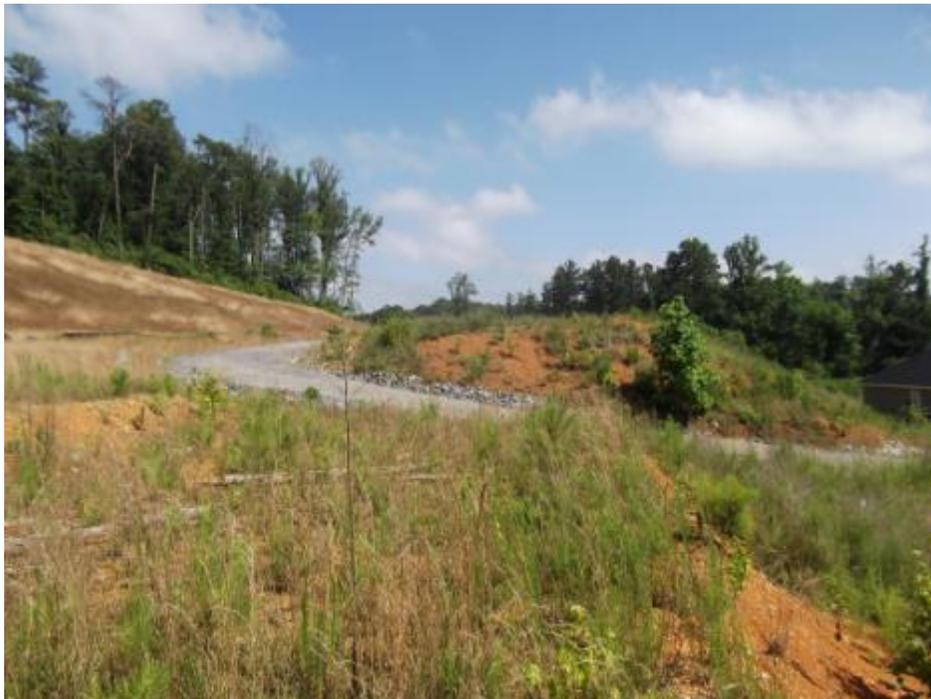
Photograph No. 2	General Site View – Southeast looking Northwest
Project No.	Date	The site is undeveloped with a gravel access road leading from Centennial Pkwy up and to the north.
12-034	May 30, 2012

A gravel access road is located on the site that connects to Beulah Drive at the entrance (southeast corner), goes a short distance to the west and then turns to the north. Based on physical observations, the gravel road does not appear to have been used as an avenue for disposal of hazardous substances or petroleum products on the subject site. Beulah Drive is a small two-lane road connecting the single-family residences nearby and the adjoining apartment complex with Cleveland Highway, a major five-lane thoroughfare through the City of Dalton.

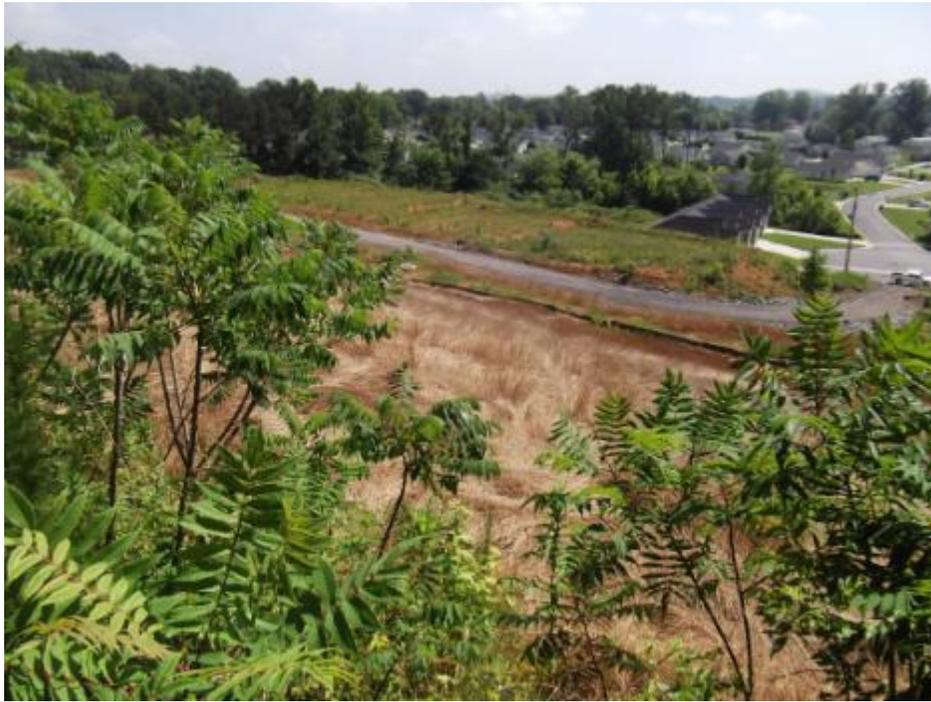
Photograph No. 3	General Site View – Southwest looking Southeast
Project No.	Date	The majority of the site is covered in tall grasses for erosion control purposes.
12-034	May 30, 2012

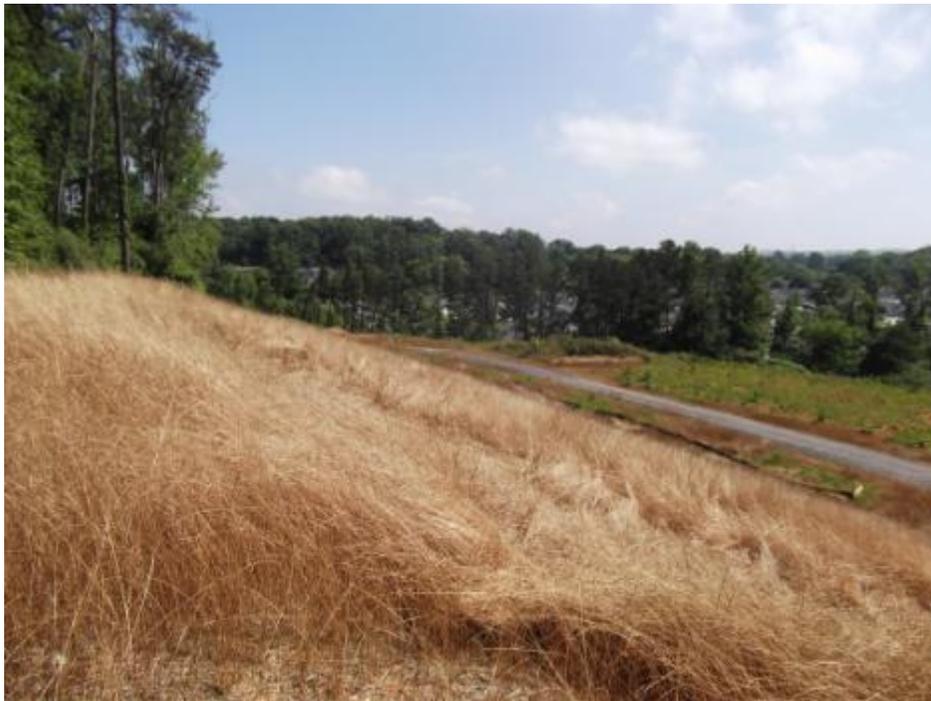
Photograph No. 4	General Site View – Middle West looking Northeast
Project No.	Date	Slope is located along the west side of the site with the top terminating at the property boundary.
12-034	May 30, 2012

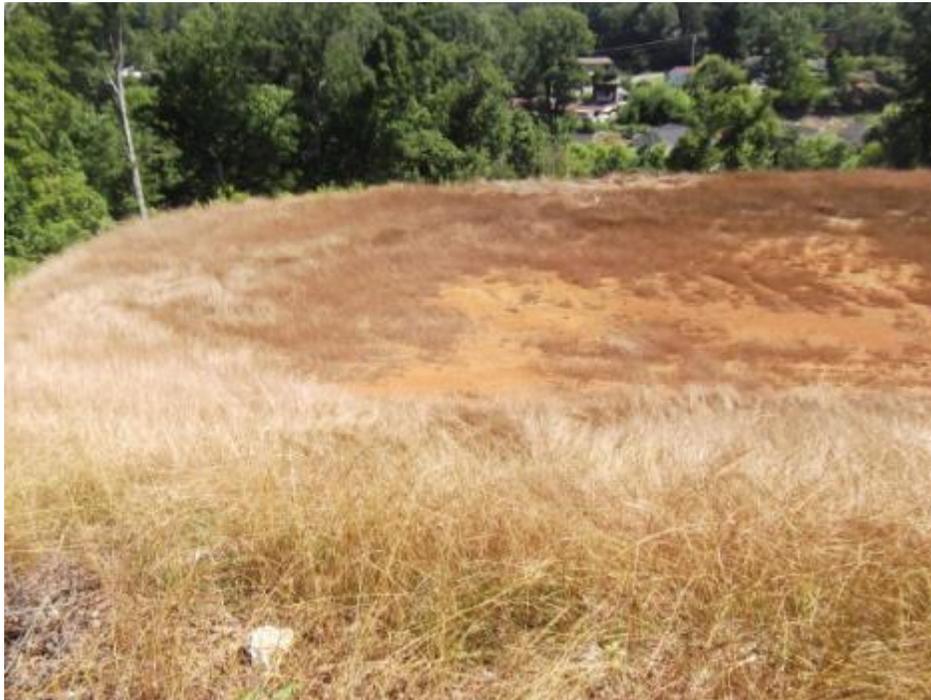
Photograph No. 5	General Site View – Northwest Corner
Project No.	Date	View of the north end of the site looking down toward the extreme north edge of the property. A small stream is located at the base of the slope in the wooded area.
12-034	May 30, 2012

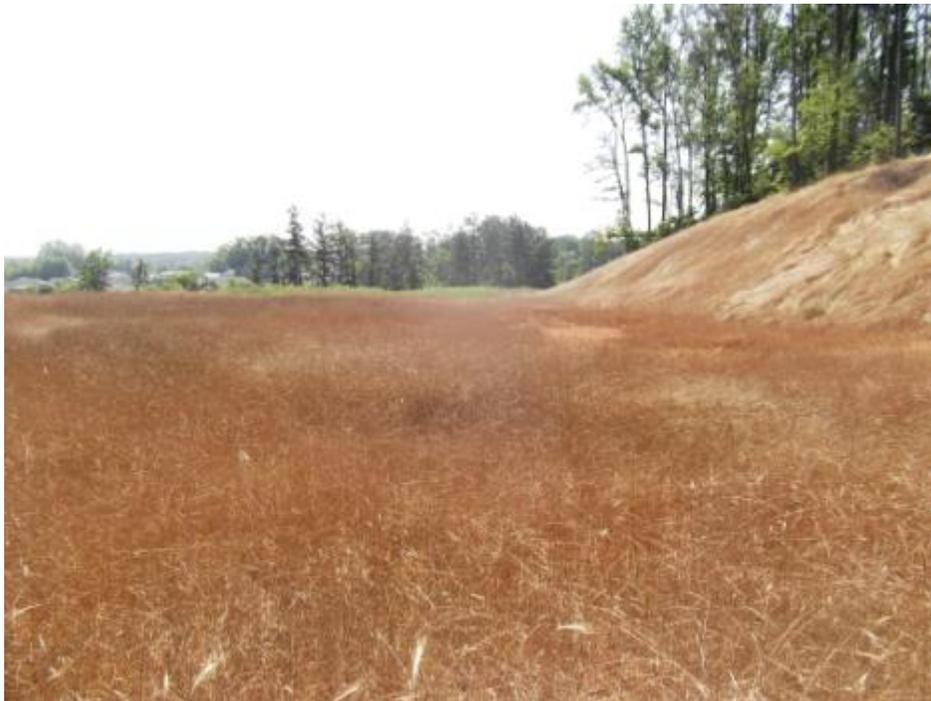
Photograph No. 6	General Site View – Northwest looking Southeast
Project No.	Date	Tall grasses cover the majority of the site.
12-034	May 30, 2012

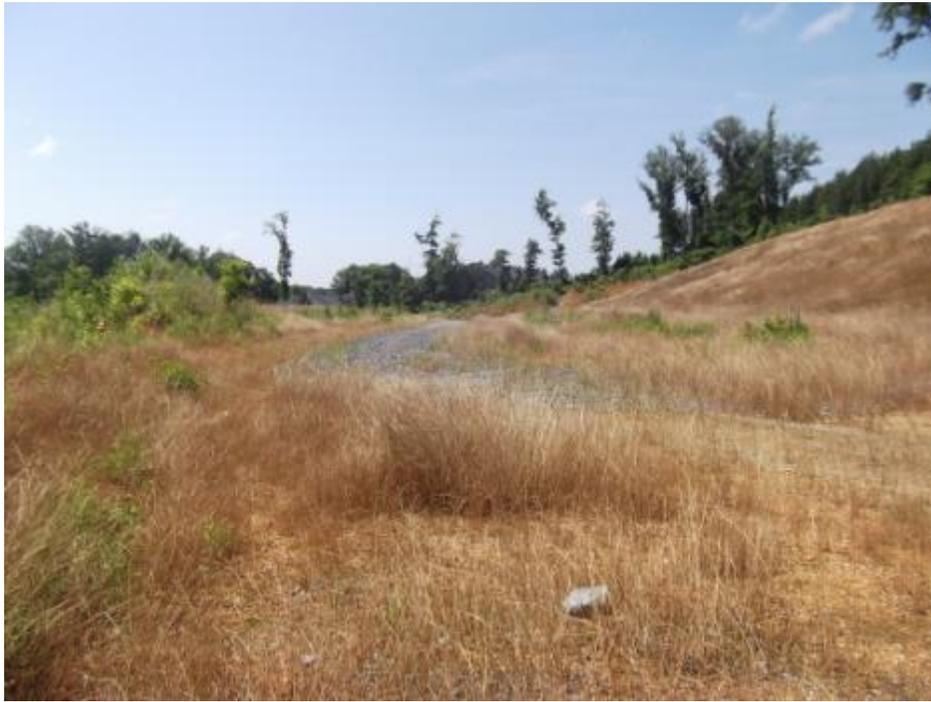
Photograph No. 7	General Site View – North looking South
Project No.	Date	This view is across the middle of the property.
12-034	May 30, 2012

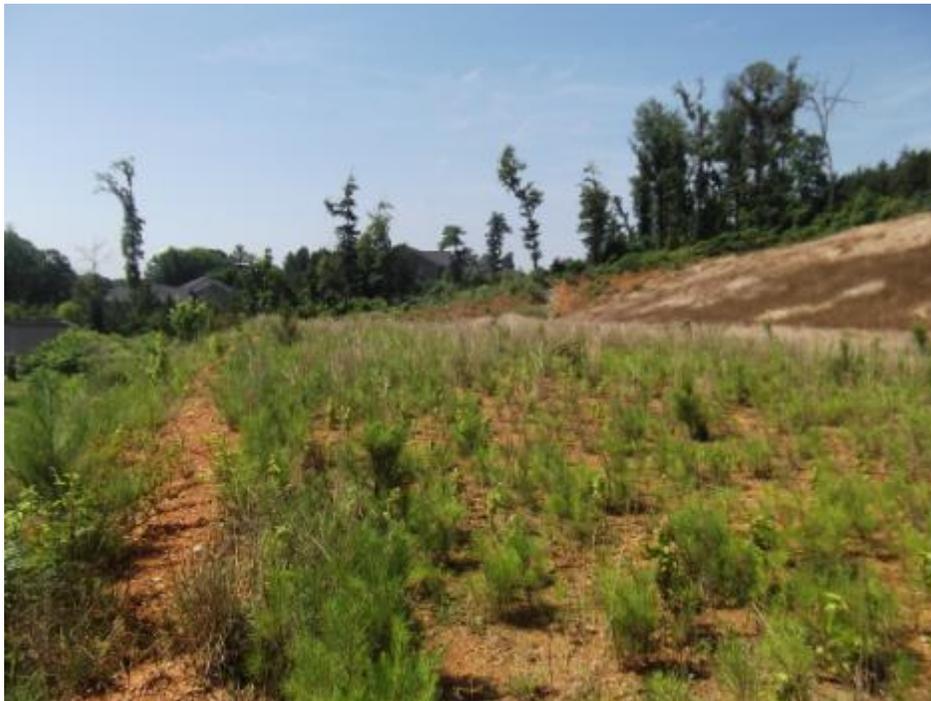
Photograph No. 8	General Site View – Middle of Site looking Southeast
Project No.	Date	Scrub pines, brush and tall grasses cover this area of the site.
12-034	May 30, 2012

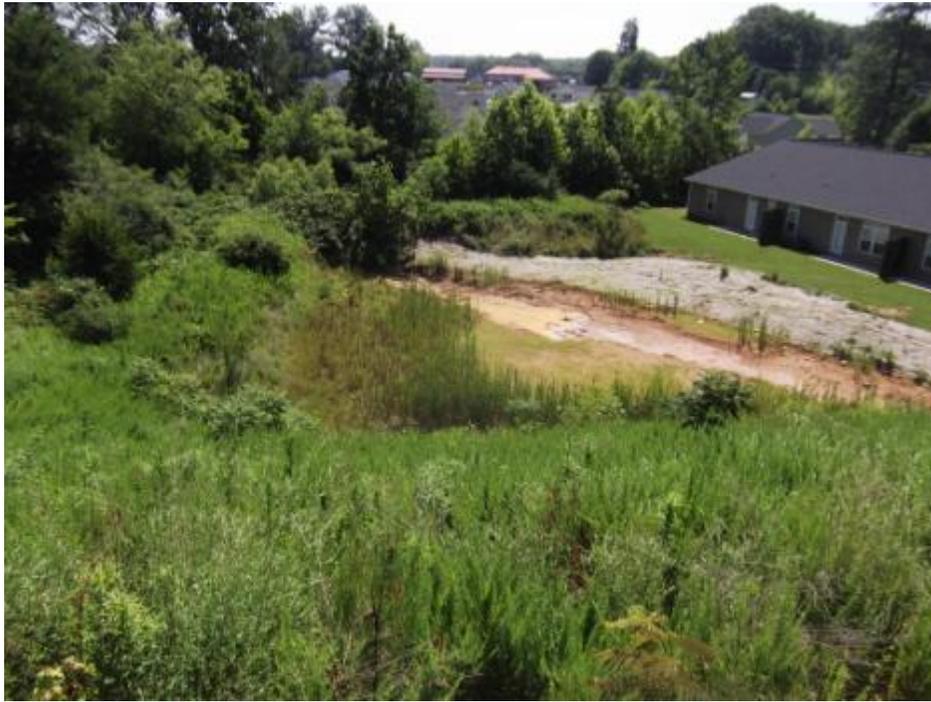
Photograph No. 9	Stormwater Detention Pond (East/Southeast Corner)
Project No.	Date	A stormwater detention pond is located on the site at the base of the east slope, which discharges to the stream along the east property boundary.
12-034	May 30, 2012

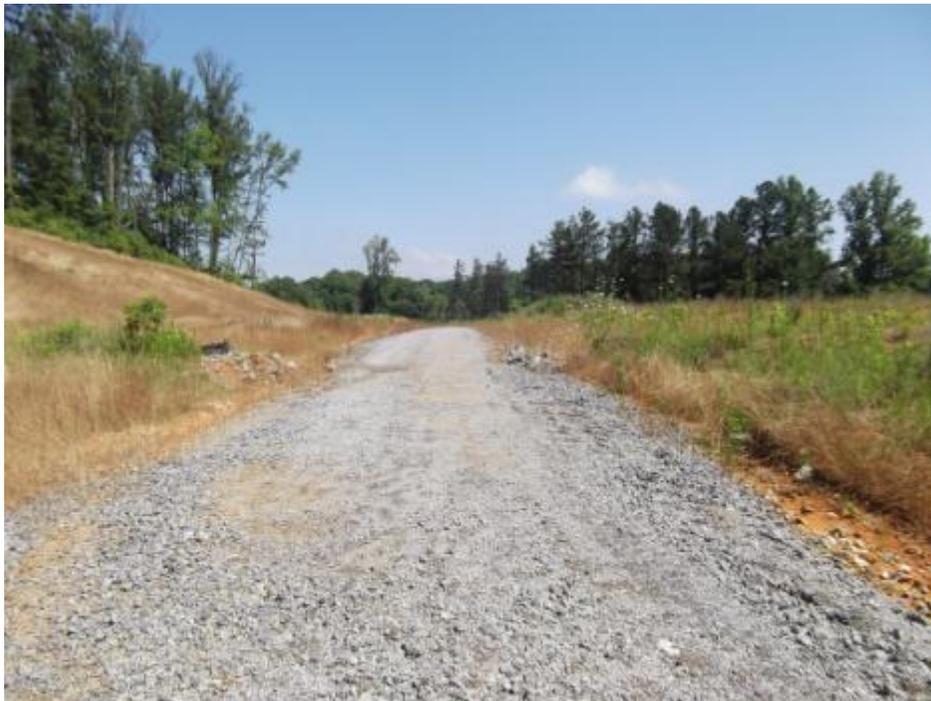
Photograph No. 10	Gravel Access Road
Project No.	Date	View of the gravel access road that leads from the site entrance on the southeast corner up and around to the middle of the site toward the north end.
12-034	May 30, 2012

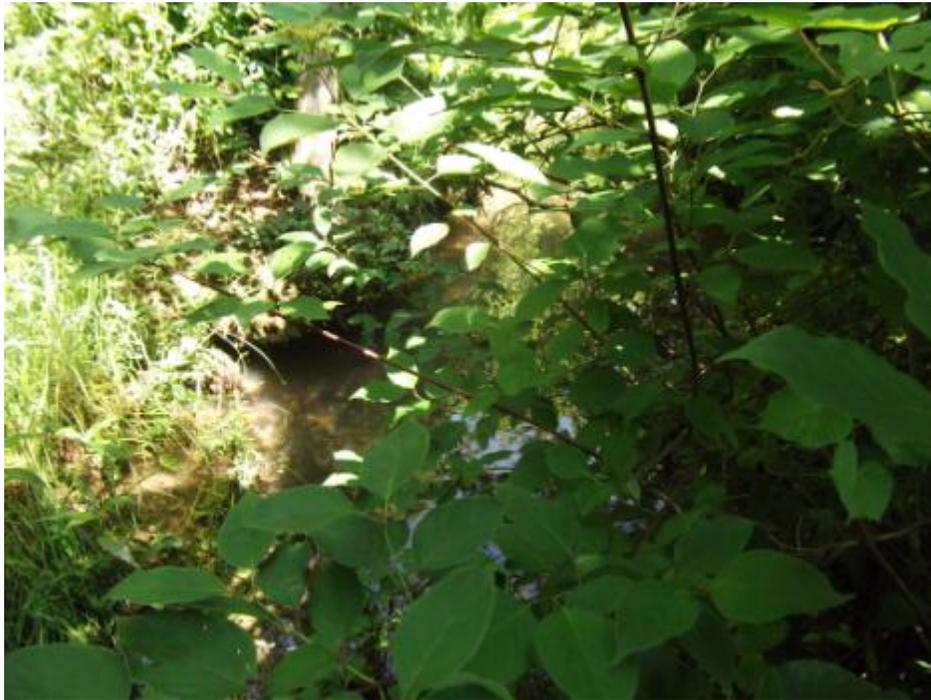
Photograph No. 11	Stream
Project No.	Date	View of small stream that forms the north and east property boundary, which flows in a southeasterly direction offsite.
12-034	May 30, 2012

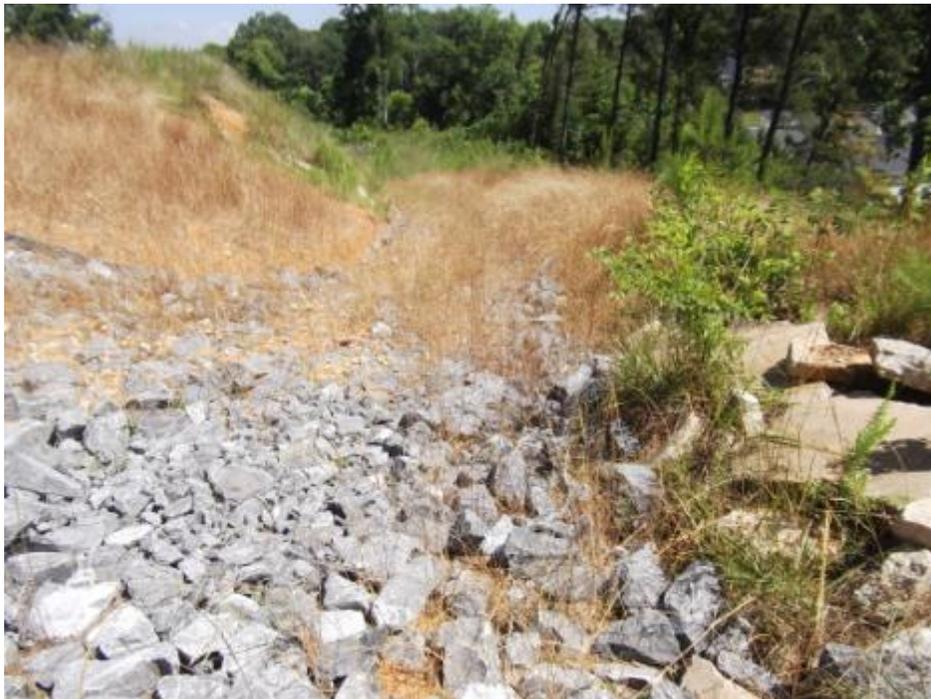
Photograph No. 12	Gravel Drainage Path to Detention Pond
Project No.	Date	A drainage swale lined with rip rap for storm water runoff on the site is located on the east side (middle) and discharges to the detention pond at the northeast corner of the property.
12-034	May 30, 2012

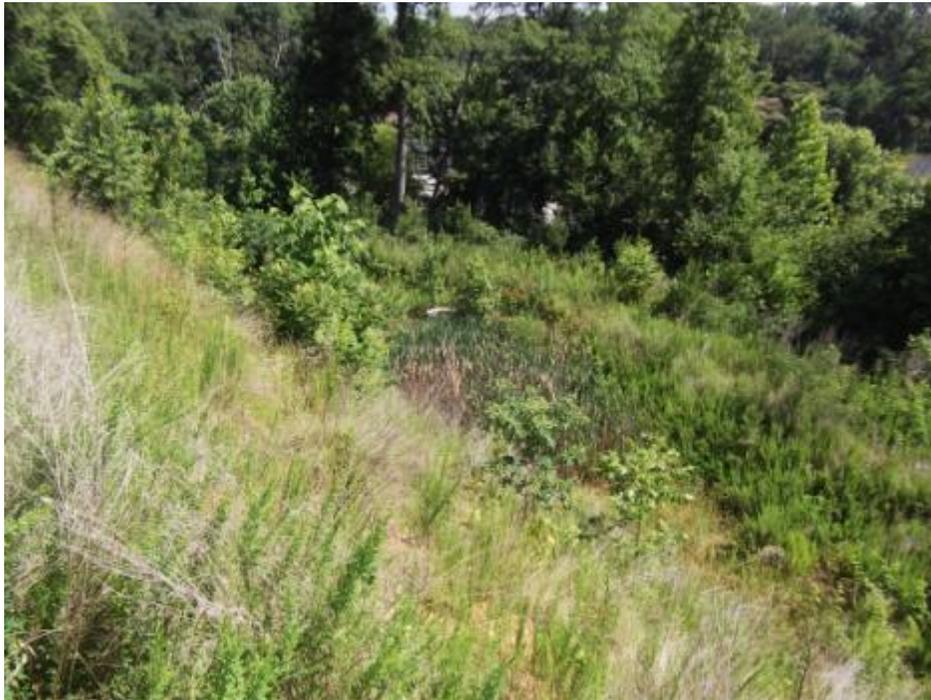
Photograph No. 13	Stormwater Detention Pond
Project No.	Date	View of the smaller detention pond located near the northeast corner, which eventually discharges into the small stream that forms the property boundary to the east.
12-034	May 30, 2012

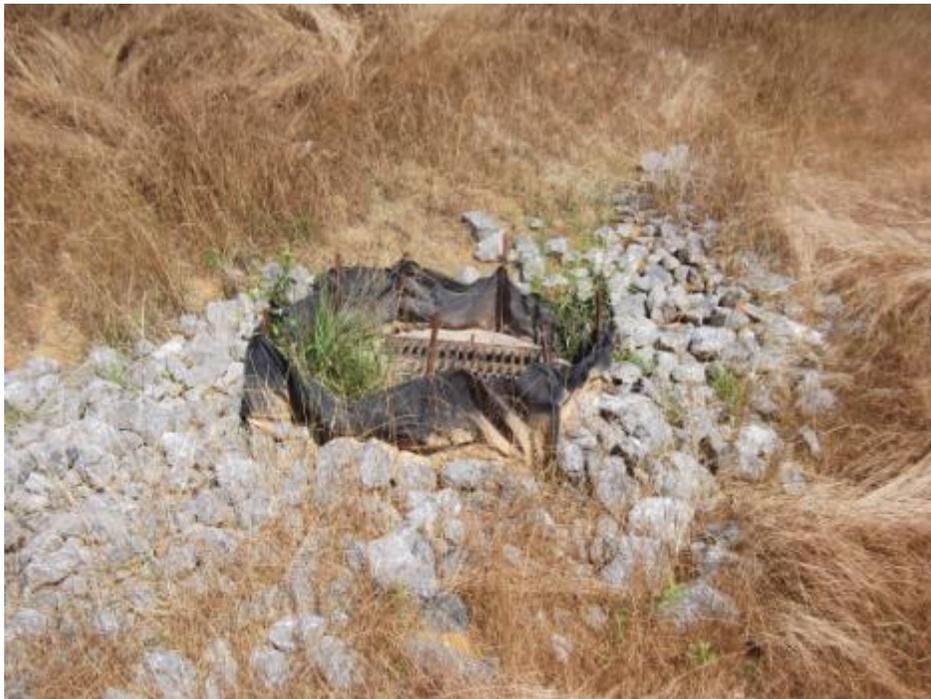
Photograph No. 14	Typical Stormwater Drain Inlet
Project No.	Date	View of a typical stormwater drain inlet that connects to the onsite detention ponds via underground piping.
12-034	May 30, 2012

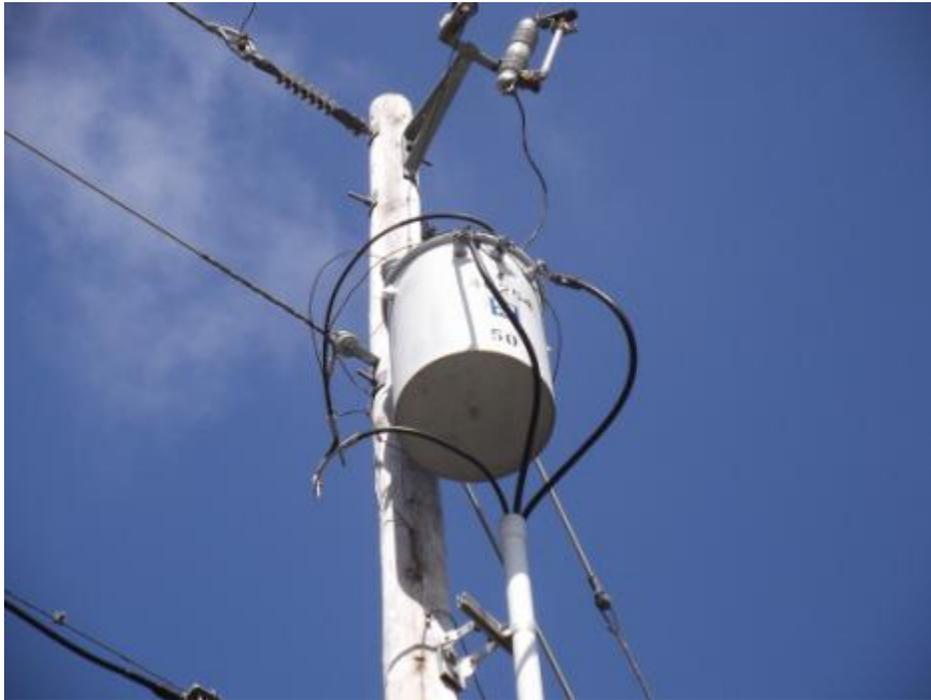
Photograph No. 15	Power Transformer
Project No.	Date	A pole-mounted power transformer was located adjacent to the main entrance at the southeast corner of the site. The transformer is labeled as "Non-PBC" containing.
12-034	May 30, 2012

PCBs are toxic chemicals previously utilized in coolants and lubricating oils in some electrical power transformers, fluorescent light ballasts, hydraulic equipment, and other similar equipment. In the case of power transformers, the utility company typically owns the equipment and is responsible for the maintenance, repair, or replacement of leaking or damaged units. One (1) pole-mounted transformer was observed on the subject site near the entrance at the southeast corner. The transformer is owned and operated by Dalton Utilities and was labeled as "Non-PCB". *It is our opinion the presence of non-PCB power transformers on the property is not an environmental concern.*

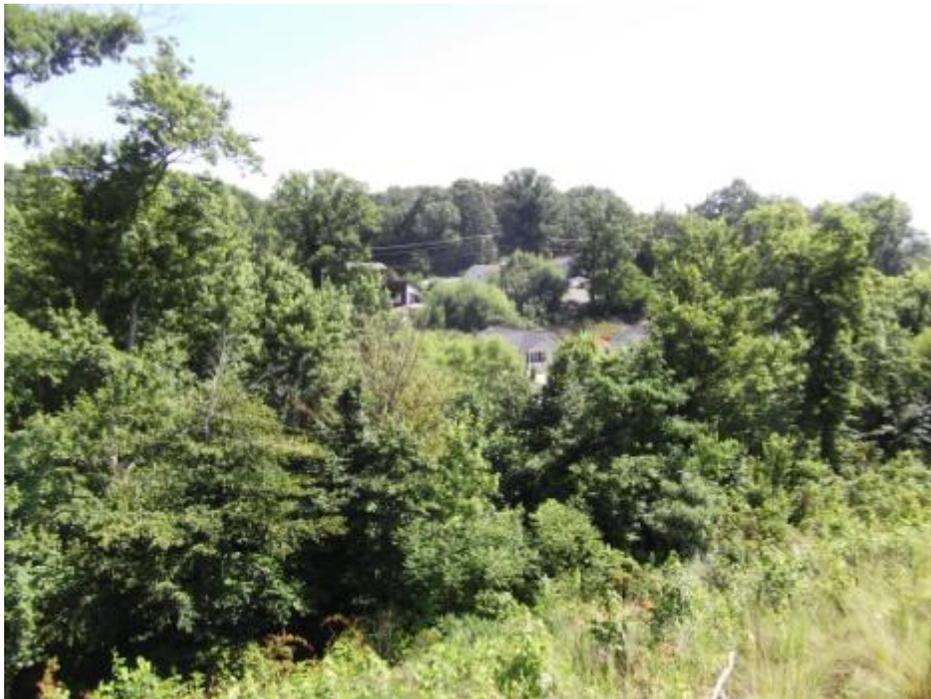
Photograph No. 16	North Adjoining Property
Project No.	Date	The Oaks at Century Place residential subdivision comprised of single-family homes separated by a wooded buffer and stream.
12-034	May 30, 2012

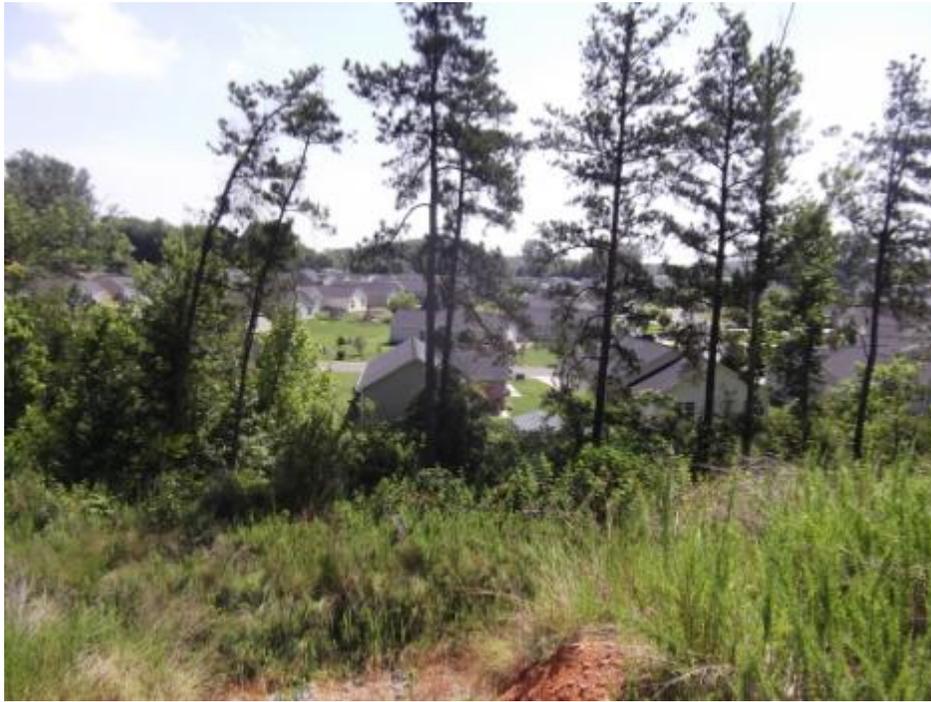
Photograph No. 17	East Adjoining Property (North and Middle Section)
Project No.	Date	The Oaks at Century Place residential subdivision comprised of single-family homes separated by a wooded buffer and stream.
12-034	May 30, 2012

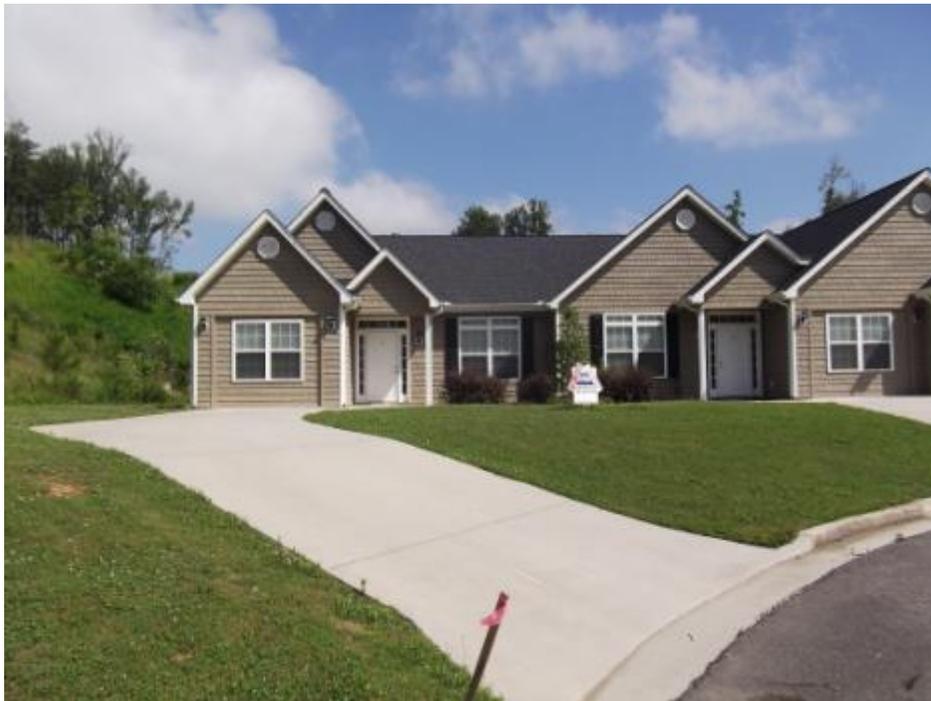
Photograph No. 18	Southeast Adjoining Property (North Side of Entrance)
Project No.	Date	Single townhome building with four units.
12-034	May 30, 2012

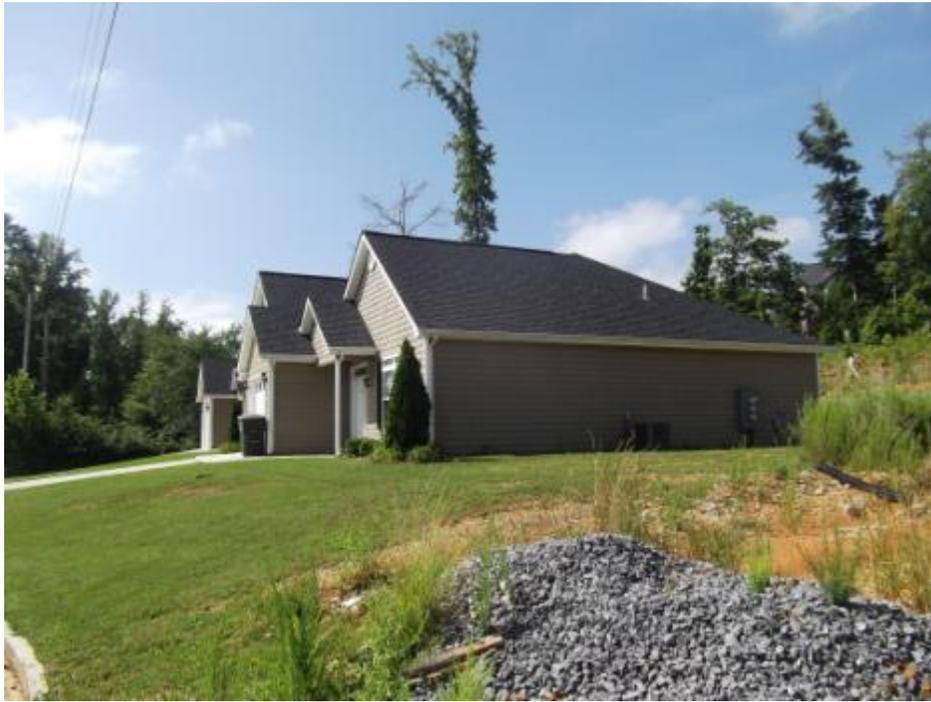
Photograph No. 19	Southeast Adjoining Property (South Side of Entrance)
Project No.	Date	Single townhome building with three units.
12-034	May 30, 2012

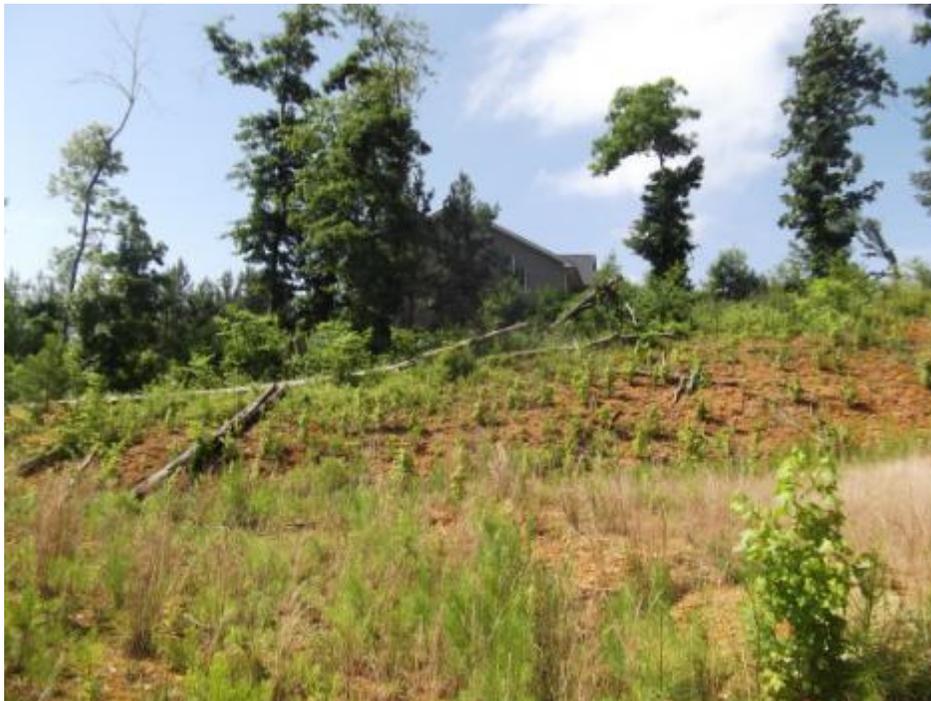
Photograph No. 20	South Adjoining Property
Project No.	Date	Autumn Ridge Apartments, a multi-family residential complex, separated by a wooded buffer.
12-034	May 30, 2012

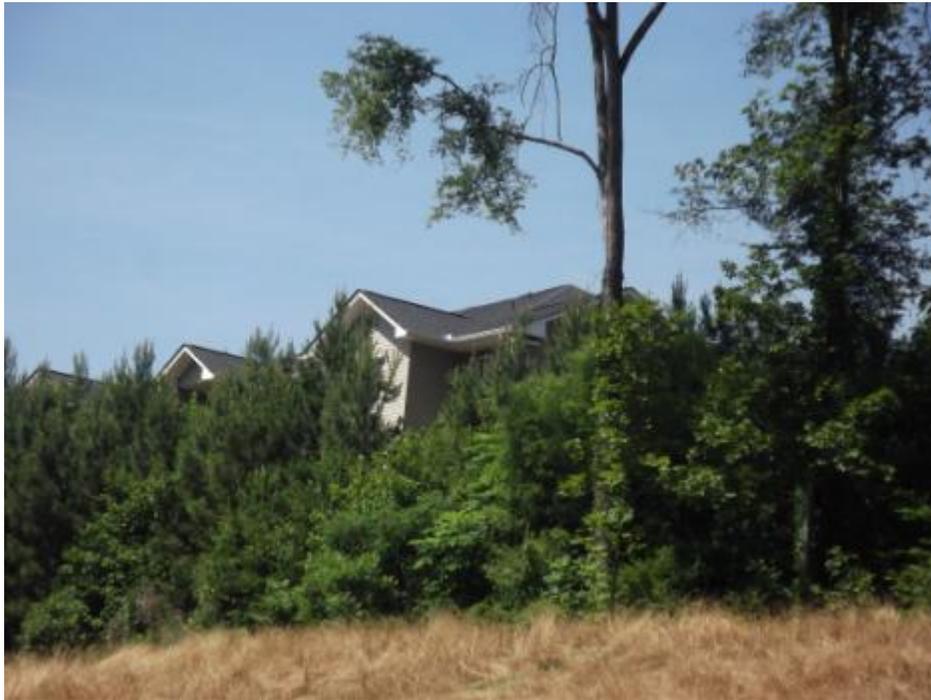
Photograph No. 21	West Adjoining Property (Southern Half)
Project No.	Date	Autumn Ridge Apartments, a multi-family residential complex, separated by a wooded buffer.
12-034	May 30, 2012

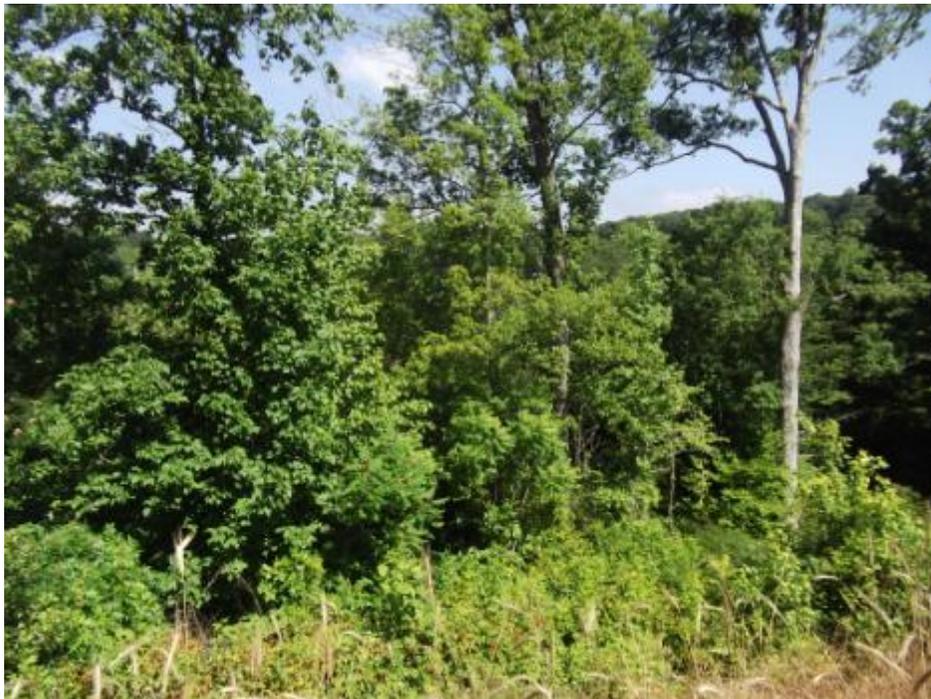
Photograph No. 22	West Adjoining Property (Northern Half)
Project No.	Date	Undeveloped woods with a few single-family homes further west.
12-034	May 30, 2012
